Access Compliance Report

Public Rights-of-Way

(Curb Ramps)

Intersection ID: 2454	Main Street: CLARKE_CREEK_PY	Cross Street: MILLSTREAM_RIDGE_DR	Location: S
ADA ID: F7956C98F41E	Ramp Type: PerpDiag	Initial Pass/Fail: Fail	Overall Compliance: No
Severity Score: 21.25			
Codes/Mitigation Info/Possible Solution		Field Measurements/Component Compliance

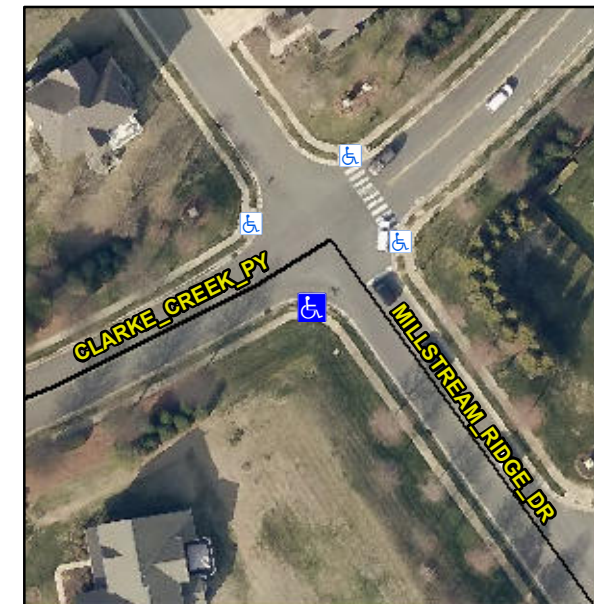
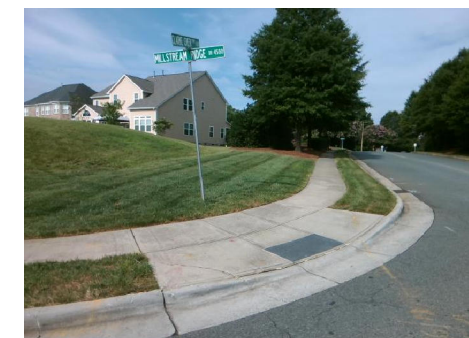
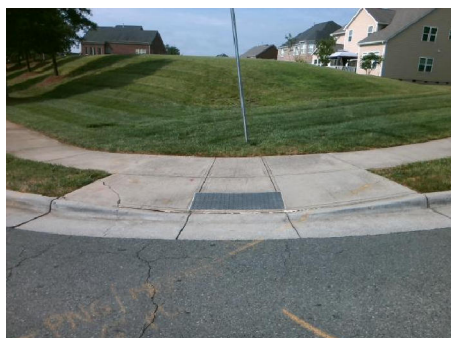
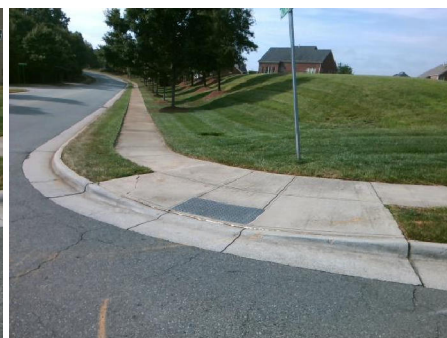
Not Found, R304.5.1, R304.5.3

Compliance	Description	Data	Compliance	Description	Data
N/A	Ramp Length (in)	53.0	Yes	Ramp Slope (%)	6.8
No	Ramp Width (in)	43.0	No	Ramp XSlope (%)	6.5
N/A	Flare Type LT	N/A	N/A	Flare Type RT	N/A
N/A	Flare Slope LT (%)	N/A	N/A	Flare Slope RT (%)	N/A
N/A	Flare Traversable LT?	N/A	N/A	Flare Traversable RT?	N/A
N/A	Landing Length (in)	N/A	N/A	DWS Provided?	N/A
N/A	Landing Width (in)	N/A	N/A	DWS Contrast?	N/A
N/A	Landing Slope (%)	N/A	N/A	DWS Length (in)	N/A
N/A	Landing X Slope (%)	N/A	N/A	DWS Full Width?	N/A
N/A	Landing Curb? (Y/N)	N/A	N/A	DWS Offset (in)	N/A
N/A	Shared Landing?	N/A			
N/A	Gutter Ponding?	N/A	N/A	Gutter Slope (%)	N/A
N/A	Gutter Lip Ht (in)	1.0	N/A	Gutter X Slope (%)	N/A
N/A	Painted X Walk1?	No	N/A	Painted X Walk2?	No
	X Walk 1 Direction	To NE		X Walk 2 Direction	To NW
N/A	X Walk 1 Width (in)	N/A	N/A	X Walk 2 Width (in)	N/A
	X Walk 1 Slope (%)	3.6		X Walk 2 Slope (%)	5.4
	X Walk 1 X Slope (%)	7.2		X Walk 2 X Slope (%)	3.6

N/A	Ramp inside XWalk1?	N/A	N/A	Ramp inside XWalk2?	N/A
	Road Slope (%)	6.4	N/A	Clear Space?	N/A
	Road X Slope (%)	3.2	N/A	Clear Space to XWalk (in)	N/A
N/A	Any Obstructions?	N/A	N/A	Storm Grate/Utility Hazard?	N/A
	Obstruction Type			Storm Grate/Utility Type	
		N/A			N/A
			Yes	Surface Condition? (G/P)	Good

Remove & Replace Curb Ramp With Two New Directional Ramps or Equivalent.
