Access Compliance Report

Public Rights-of-Way

(Curb Ramps)

Intersection ID: 18152	Main Street: BEECHDALE_DR	Cross Street: OLD_POST_RD	Location: E
ADA ID: F796BDD30C6F	Ramp Type: PerpDiag	Initial Pass/Fail: Fail	Overall Compliance: No
Severity Score: 10			
Codes/Mitigation Info/Possible Solution		Field Measurements/Component Compliance

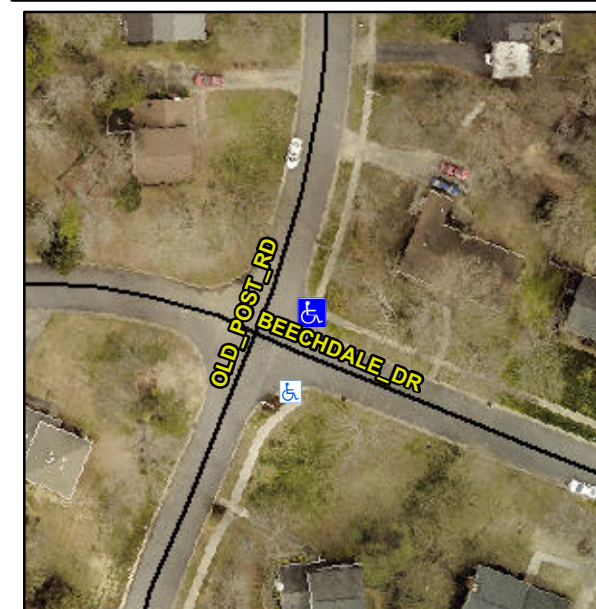
Not Found, R304.5.1, R304.5.3

Compliance	Description	Data	Compliance	Description	Data
N/A	Ramp Length (in)	41.0	Yes	Ramp Slope (%)	5.5
No	Ramp Width (in)	36.0	No	Ramp XSlope (%)	2.9
N/A	Flare Type LT	N/A	N/A	Flare Type RT	N/A
N/A	Flare Slope LT (%)	N/A	N/A	Flare Slope RT (%)	N/A
N/A	Flare Traversable LT?	N/A	N/A	Flare Traversable RT?	N/A
N/A	Landing Length (in)	N/A	N/A	DWS Provided?	N/A
N/A	Landing Width (in)	N/A	N/A	DWS Contrast?	N/A
N/A	Landing Slope (%)	N/A	N/A	DWS Length (in)	N/A
N/A	Landing X Slope (%)	N/A	N/A	DWS Full Width?	N/A
N/A	Landing Curb? (Y/N)	N/A	N/A	DWS Offset (in)	N/A
N/A	Shared Landing?	N/A			
N/A	Gutter Ponding?	N/A	N/A	Gutter Slope (%)	N/A
N/A	Gutter Lip Ht (in)	N/A	N/A	Gutter X Slope (%)	N/A
N/A	Painted X Walk1?	No	N/A	Painted X Walk2?	No
	X Walk 1 Direction	To NW		X Walk 2 Direction	To SW
N/A	X Walk 1 Width (in)	N/A	N/A	X Walk 2 Width (in)	N/A
	X Walk 1 Slope (%)	3.0		X Walk 2 Slope (%)	0.1
	X Walk 1 X Slope (%)	1.2		X Walk 2 X Slope (%)	4.3

N/A	Ramp inside XWalk1?	N/A	N/A	Ramp inside XWalk2?	N/A
	Road Slope (%)	3.3	N/A	Clear Space?	N/A
	Road X Slope (%)	2.1	N/A	Clear Space to XWalk (in)	N/A
N/A	Any Obstructions?	N/A	N/A	Storm Grate/Utility Hazard?	N/A
	Obstruction Type			Storm Grate/Utility Type	
		N/A			N/A
			Yes	Surface Condition? (G/P)	Good

Possible Solutions:

Remove & Replace Curb Ramp With Two New Directional Ramps or Equivalent.
