Access Compliance Report

Public Rights-of-Way (Curb Ramps)

Intersection ID: 22573	Main Street: INDIAN_HILLS_LN	Cross Street: SEASCAPE_LN	Location: NE
ADA ID: F79FF1AC2EF9	Ramp Type: Directional1	Initial Pass/Fail: Fail	Overall Compliance: No
Severity Score: 22.5			
Codes/Mitigation Info/Possible Solution		Field Measurements/Component Compliance

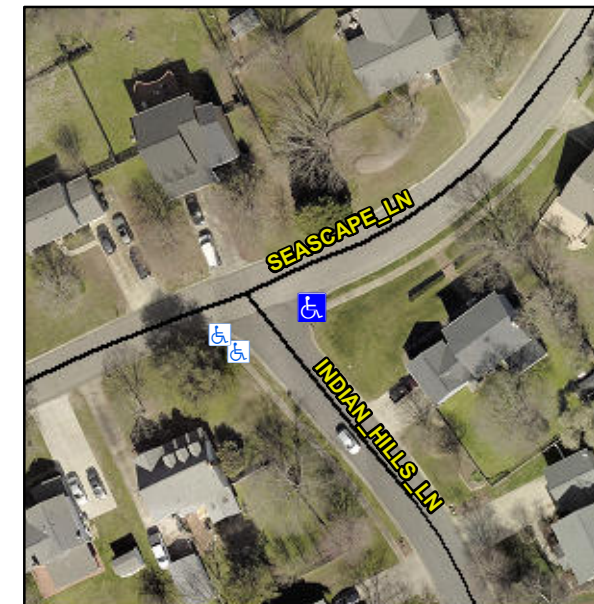
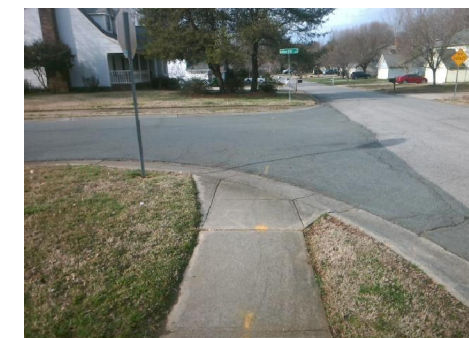
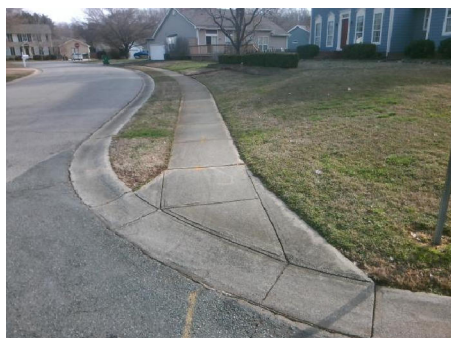
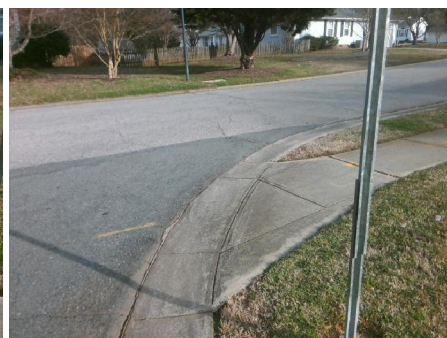
Compliance	Description	Data	Compliance	Description	Data
N/A	Ramp Length (in)	48.0	N/A	Grade Break?	N/A
No	Ramp Width (in)	47.0	N/A	Grade Break Slope (%)	0.0
No	Ramp Slope (%)	9.1	N/A	Grade Break XSlope (%)	0.0
No	Ramp XSlope (%)	4.0			
N/A	Flare Type LT	N/A	N/A	Flare Type RT	N/A
N/A	Flare Slope LT (%)	N/A	N/A	Flare Slope RT (%)	0.0
N/A	Flare Traversable LT?	N/A	N/A	Flare Traversable RT?	N/A
N/A	Landing Length (in)	0.0	N/A	DWS Provided?	N/A
N/A	Landing Width (in)	0.0	N/A	DWS Contrast?	N/A
N/A	Landing Slope (%)	0.0	N/A	DWS Length (in)	N/A
N/A	Landing X Slope (%)	0.0	N/A	DWS Full Width?	N/A
N/A	Landing Curb? (Y/N)	N/A	N/A	DWS Offset LT (in)	N/A
N/A	Shared Landing?	N/A	N/A	DWS Offset RT (in)	N/A
N/A	Gutter Ponding?	0.0	N/A	Gutter Slope (%)	N/A
N/A	Gutter Lip Ht (in)	0.0	N/A	Gutter X Slope (%)	N/A
N/A	Painted X Walk1?	No		Road Slope (%)	2.1
	X Walk 1 Direction	To SW		Road X Slope (%)	1.0
	X Walk 1 Width (in)	N/A		Clear Space?	N/A

X Walk 1 Slope (%)	2.1	N/A	Clear Space to XWalk (in)	N/A
	X Walk 1 X Slope (%)	1.0	N/A	Storm Grate/Utility Hazard?	N/A
N/A	Ramp inside XWalk1?	N/A		Storm Grate/Utility Type	
N/A	Any Obstructions?	N/A			N/A
	Obstruction Type		Yes	Surface Condition? (G/P)	Good
			N/A	Curb Slope (%)	8.8

Remove & Replace Entire Ramp.
