# Access Compliance Report

## Public Rights-of-Way

### (Curb Ramps)

| Intersection ID: 44190 | Main Street: ROZZELLES_LANDING_DR | Cross Street: CODDINGTON_RIDGE_DR | Location: NW |

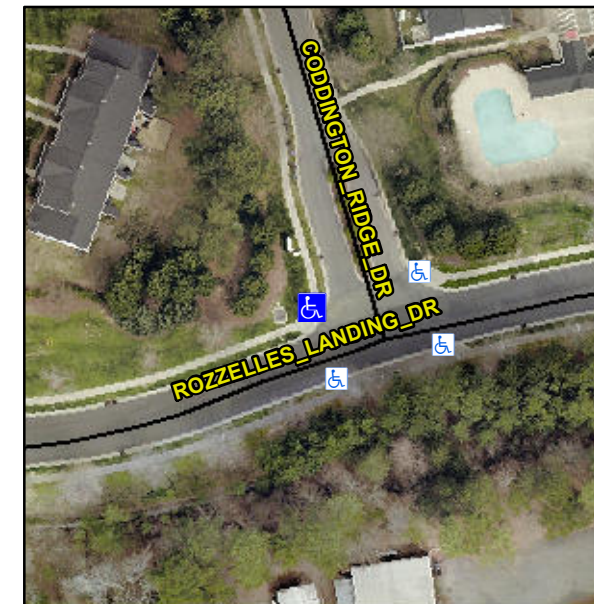
| ADA ID: F7A826F2D84C | Ramp Type: PerpDiag | Initial Pass/Fail: Fail | Overall Compliance: No |
| Severity Score: 8.75 | | | |

**Not Found, R304.5.1**

| Compliance | Description | Data | Compliance | Description | Data |
|---|---|---|---|---|---|
| No | Ramp Width (in) | 41.0 | Yes | Ramp XSlope (%) | 0.1 |

Possible Solutions:

**Remove & Replace Curb Ramp With Two New Directional Ramps or Equivalent.**
