Access Compliance Report

Public Rights-of-Way

(Curb Ramps)

Intersection ID: 26310	Main Street: BEVINGTON_PL	Cross Street: BEVINGTON_RIDGE_RD	Location: NW
ADA ID: F7ADCA8A510B	Ramp Type: PerpDiag	Initial Pass/Fail: Fail	Overall Compliance: No
Severity Score: 33.75			
Codes/Mitigation Info/Possible Solution		Field Measurements/Component Compliance

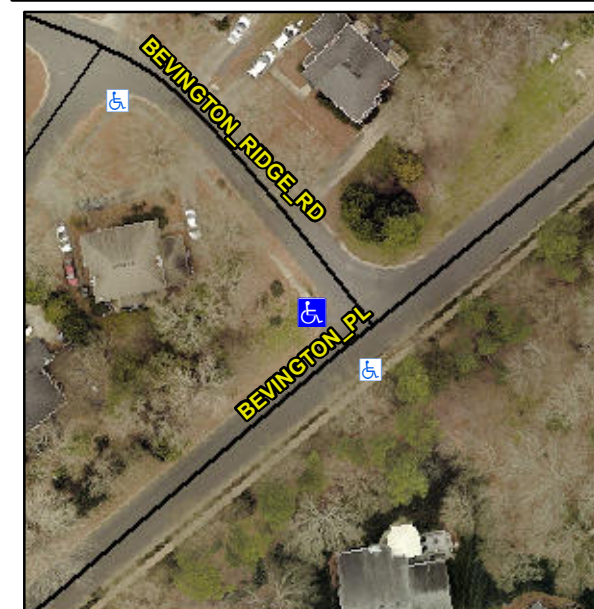
Compliance	Description	Data	Compliance	Description	Data
N/A	Ramp Length (in)	65.0	No	Ramp Slope (%)	10.0
No	Ramp Width (in)	47.0	No	Ramp XSlope (%)	5.2
N/A	Flare Type LT	N/A	N/A	Flare Type RT	N/A
N/A	Flare Slope LT (%)	N/A	N/A	Flare Slope RT (%)	N/A
N/A	Flare Traversable LT?	N/A	N/A	Flare Traversable RT?	N/A
N/A	Landing Length (in)	N/A	N/A	DWS Provided?	N/A
N/A	Landing Width (in)	N/A	N/A	DWS Contrast?	N/A
N/A	Landing Slope (%)	N/A	N/A	DWS Length (in)	N/A
N/A	Landing X Slope (%)	N/A	N/A	DWS Full Width?	N/A
N/A	Landing Curb? (Y/N)	N/A	N/A	DWS Offset (in)	N/A
N/A	Shared Landing?	N/A			
N/A	Gutter Ponding?	N/A	N/A	Gutter Slope (%)	N/A
N/A	Gutter Lip Ht (in)	N/A	N/A	Gutter X Slope (%)	N/A
N/A	Painted X Walk1?	No	N/A	Painted X Walk2?	No
	X Walk 1 Direction	To SE		X Walk 2 Direction	To NE
N/A	X Walk 1 Width (in)	N/A	N/A	X Walk 2 Width (in)	N/A
	X Walk 1 Slope (%)	3.0		X Walk 2 Slope (%)	3.6
	X Walk 1 X Slope (%)	2.6		X Walk 2 X Slope (%)	3.4

N/A	Ramp inside XWalk1?	N/A	N/A	Ramp inside XWalk2?	N/A
	Road Slope (%)	2.0	N/A	Clear Space?	N/A
	Road X Slope (%)	0.9	N/A	Clear Space to XWalk (in)	N/A
N/A	Any Obstructions?	N/A	N/A	Storm Grate/Utility Hazard?	N/A
	Obstruction Type			Storm Grate/Utility Type	
		N/A			N/A
			Yes	Surface Condition? (G/P)	Good

Remove & Replace Curb Ramp With Two New Directional Ramps or Equivalent.
