Access Compliance Report

Public Rights-of-Way

(Curb Ramps)

Intersection ID: 5563	Main Street: N I-77 EXIT 16 RA	Cross Street: N/A	Location: SW
ADA ID: F7B78B076A5B	Ramp Type: Directional1	Initial Pass/Fail: Fail	Overall Compliance: No
Severity Score: 12.5			
Codes/Mitigation Info/Possible Solution		Field Measurements/Component Compliance

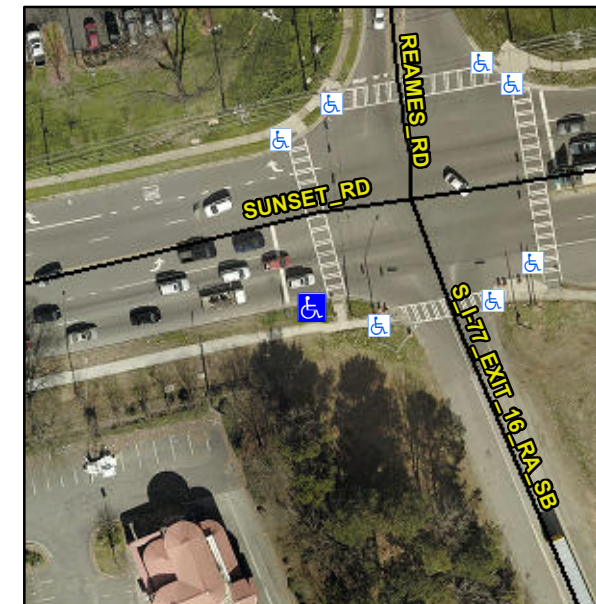
Compliance	Description	Data	Compliance	Description	Data
N/A	Ramp Length (in)	85.0	N/A	Grade Break?	N/A
Yes	Ramp Width (in)	69.0	N/A	Grade Break Slope (%)	0.0
No	Ramp Slope (%)	8.5	N/A	Grade Break XSlope (%)	0.0
Yes	Ramp XSlope (%)	0.1			
N/A	Flare Type LT	N/A	N/A	Flare Type RT	N/A
N/A	Flare Slope LT (%)	N/A	N/A	Flare Slope RT (%)	0.0
N/A	Flare Traversable LT?	N/A	N/A	Flare Traversable RT?	N/A
N/A	Landing Length (in)	0.0	N/A	DWS Provided?	N/A
N/A	Landing Width (in)	0.0	N/A	DWS Contrast?	N/A
N/A	Landing Slope (%)	0.0	N/A	DWS Length (in)	N/A
N/A	Landing X Slope (%)	0.0	N/A	DWS Full Width?	N/A
N/A	Landing Curb? (Y/N)	N/A	N/A	DWS Offset LT (in)	N/A
N/A	Shared Landing?	N/A	N/A	DWS Offset RT (in)	N/A
N/A	Gutter Ponding?	0.0	N/A	Gutter Slope (%)	N/A
N/A	Gutter Lip Ht (in)	0.0	N/A	Gutter X Slope (%)	N/A
N/A	Painted X Walk1?	Yes		Road Slope (%)	0.0
	X Walk 1 Direction	To N		Road X Slope (%)	4.3
	X Walk 1 Width (in)	112.0		Clear Space?	N/A

X Walk 1 Slope (%)	0.0	N/A	Clear Space to XWalk (in)	N/A
	X Walk 1 X Slope (%)	4.3	N/A	Storm Grate/Utility Hazard?	N/A
N/A	Ramp inside XWalk1?	Yes		Storm Grate/Utility Type	
N/A	Any Obstructions?	N/A			N/A
	Obstruction Type		Yes	Surface Condition? (G/P)	Good
			N/A	Curb Slope (%)	0.7

Remove & Replace Entire Ramp.

R304.2.2

\$ 1600.00
