Access Compliance Report

Public Rights-of-Way

(Curb Ramps)

Intersection ID: 14015	Main Street: LABURNUM_AV	Cross Street: ST_JULIEN_ST	Location: NW
ADA ID: F7C062523A68	Ramp Type: Perp	Initial Pass/Fail: Fail	Overall Compliance: No
Severity Score: 42.5			
Codes/Mitigation Info/Possible Solution		Field Measurements/Component Compliance

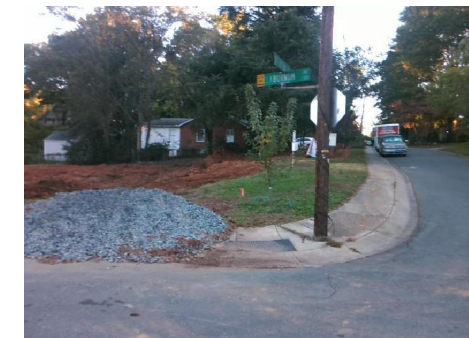
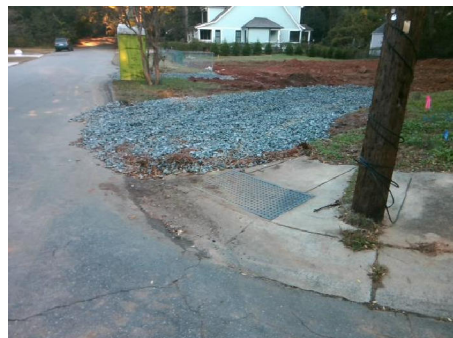
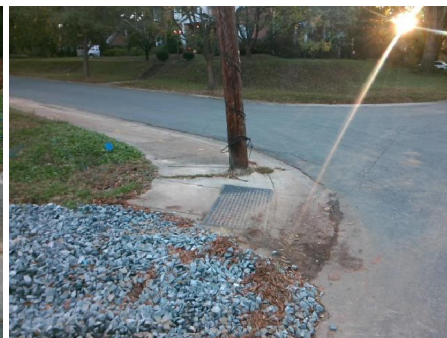
Not Found, R304.5.1, R304.2.2, R304.5.3

Compliance	Description	Data	Compliance	Description	Data
N/A	Ramp Length (in)	67.0	No	Ramp Slope (%)	9.3
No	Ramp Width (in)	32.0	No	Ramp XSlope (%)	6.2
N/A	Flare Type LT	N/A	N/A	Flare Type RT	N/A
N/A	Flare Slope LT (%)	N/A	N/A	Flare Slope RT (%)	N/A
N/A	Flare Traversable LT?	N/A	N/A	Flare Traversable RT?	N/A
N/A	Landing Length (in)	N/A	N/A	DWS Provided?	N/A
N/A	Landing Width (in)	N/A	N/A	DWS Contrast?	N/A
N/A	Landing Slope (%)	N/A	N/A	DWS Length (in)	N/A
N/A	Landing X Slope (%)	N/A	N/A	DWS Full Width?	N/A
N/A	Landing Curb? (Y/N)	N/A	N/A	DWS Offset (in)	N/A
N/A	Shared Landing?	N/A			
N/A	Gutter Ponding?	Yes	N/A	Gutter Slope (%)	N/A
N/A	Gutter Lip Ht (in)	N/A	N/A	Gutter X Slope (%)	N/A
N/A	Painted X Walk1?	No	N/A	Painted X Walk2?	N/A
	X Walk 1 Direction	To SW		X Walk 2 Direction	N/A
N/A	X Walk 1 Width (in)	N/A	N/A	X Walk 2 Width (in)	N/A
	X Walk 1 Slope (%)	1.2		X Walk 2 Slope (%)	N/A
	X Walk 1 X Slope (%)	3.5		X Walk 2 X Slope (%)	N/A

N/A	Ramp inside XWalk1?	N/A	N/A	Ramp inside XWalk2?	N/A
	Road Slope (%)	N/A	N/A	Clear Space?	N/A
	Road X Slope (%)	N/A	N/A	Clear Space to XWalk (in)	N/A
N/A	Any Obstructions?	N/A	N/A	Storm Grate/Utility Hazard?	N/A
	Obstruction Type			Storm Grate/Utility Type	
		N/A			N/A
		Yes		Surface Condition? (G/P)	Good

Remove & Replace Entire Ramp.
