# Access Compliance Report

## Public Rights-of-Way

| Intersection ID: 13133 | Main Street: S_CALDWELL_ST | Cross Street: E_STONEWALL_ST | Location: SE |
| ADA ID: F7C1CAD621F9 | Ramp Type: Perp | Initial Pass/Fail: Fail | Overall Compliance: No |

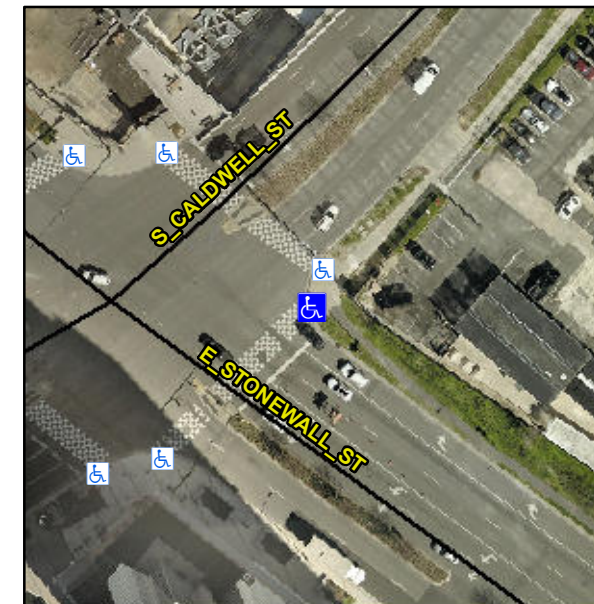
| Severity Score: 25 | | | |

**Not Found, R304.5.3**

| Compliance | Description | Data | Compliance | Description | Data |
|---|---|---|---|---|---|
| Yes | Ramp Width (in) | 72.0 | No | Ramp XSlope (%) | 7.4 |

**Remove & Replace Entire Ramp.**

Total Cost: \$ 1850.00

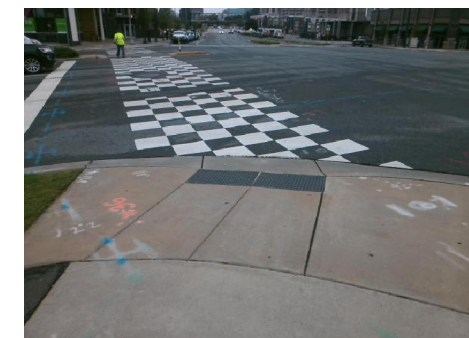
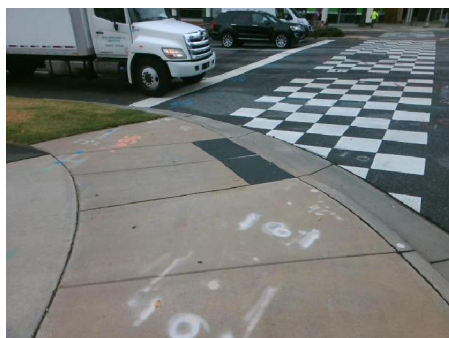
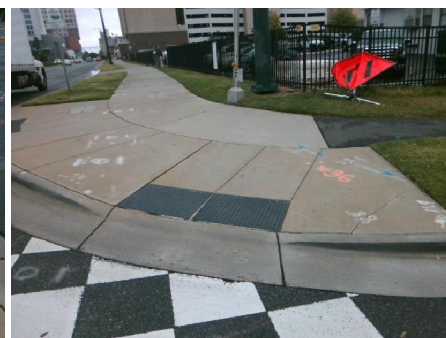
| Compliance | Description | Data | Compliance | Description | Data |
|---|---|---|---|---|---|
| | | Yes | | Surface Condition? (G/P) | Good |
