Access Compliance Report

Public Rights-of-Way

(Curb Ramps)

| Intersection ID: 29432 | Main Street: MIRTH_LN | Cross Street: PALESTRINA_RD | Location: NE |

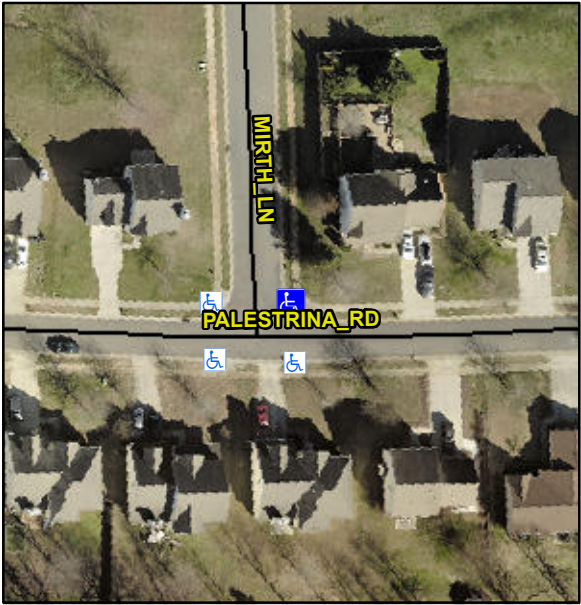
| ADA ID: F7FA56F99BDA | Ramp Type: PerpDiag | Initial Pass/Fail: Fail | Overall Compliance: No |

| Codes/Mitigation Info/Possible Solution | | Field Measurements/Component Compliance | | | | | |
|--|---|---|---|---|---|---|---|
| | <p>Surveyor Notes:</p> <p>N/A</p> <p>PROW/ADA:</p> <p>R304.5.1, R304.5.3</p> | N/A | Ramp Length (in) | 47.5 | Yes | Ramp Slope (%) | 7.9 |
| | | No | Ramp Width (in) | 45.5 | No | Ramp XSlope (%) | 6.6 |

| Codes/Mitigation Info/Possible Solution | | Field Measurements/Component Compliance | | | | | |
|--|---|---|---|---|---|---|---|
| | <p>Possible Solutions:</p> <p>Remove & Replace Curb Ramp With Two New Directional Ramps or Equivalent.</p> | Compliance | Description | Data | Compliance | Description | Data |
