# Access Compliance Report

## Public Rights-of-Way

### (Curb Ramps)

Intersection ID: 48571	Main Street: DAPPLE_CT	Cross Street: SALAMANDER_RUN_LN	Location:	E
ADA ID: F7FA83617432	Ramp Type: PerpDiag	Initial Pass/Fail: Fail	Overall Compliance: No	Severity Score: 10
Codes/Mitigation Info/Possible Solution		Field Measurements/Component Compliance

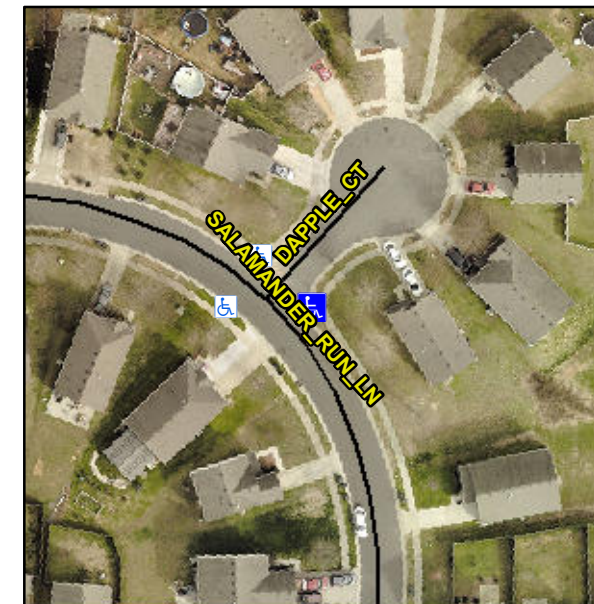
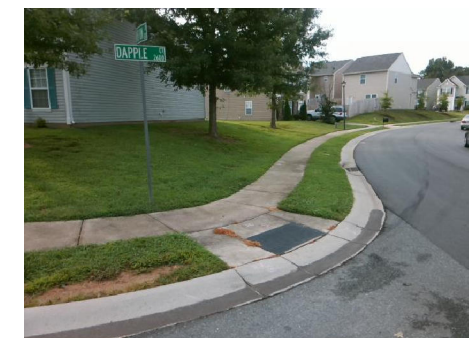
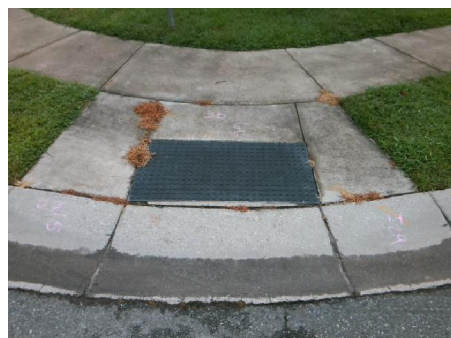
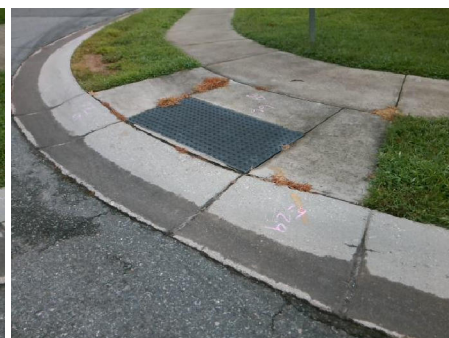
**Not Found, R304.5.1, R304.5.3**

Compliance	Description	Data	Compliance	Description	Data
N/A	Ramp Length (in)	47.0	Yes	Ramp Slope (%)	6.6
No	Ramp Width (in)	47.5	No	Ramp XSlope (%)	3.0
N/A	Flare Type LT	N/A	N/A	Flare Type RT	N/A
N/A	Flare Slope LT (%)	N/A	N/A	Flare Slope RT (%)	N/A
N/A	Flare Traversable LT?	N/A	N/A	Flare Traversable RT?	N/A
N/A	Landing Length (in)	N/A	N/A	DWS Provided?	N/A
N/A	Landing Width (in)	N/A	N/A	DWS Contrast?	N/A
N/A	Landing Slope (%)	N/A	N/A	DWS Length (in)	N/A
N/A	Landing X Slope (%)	N/A	N/A	DWS Full Width?	N/A
N/A	Landing Curb? (Y/N)	N/A	N/A	DWS Offset (in)	N/A
N/A	Shared Landing?	N/A			
N/A	Gutter Ponding?	Yes	N/A	Gutter Slope (%)	N/A
N/A	Gutter Lip Ht (in)	0.75	N/A	Gutter X Slope (%)	N/A
N/A	Painted X Walk1?	No	N/A	Painted X Walk2?	No
	X Walk 1 Direction	To NW		X Walk 2 Direction	To SW
N/A	X Walk 1 Width (in)	N/A	N/A	X Walk 2 Width (in)	N/A
	X Walk 1 Slope (%)	1.5		X Walk 2 Slope (%)	2.9
	X Walk 1 X Slope (%)	0.7		X Walk 2 X Slope (%)	1.9

N/A	Ramp inside XWalk1?	N/A	N/A	Ramp inside XWalk2?	N/A
	Road Slope (%)	0.8	N/A	Clear Space?	N/A
	Road X Slope (%)	2.3	N/A	Clear Space to XWalk (in)	N/A
N/A	Any Obstructions?	N/A	N/A	Storm Grate/Utility Hazard?	N/A
	Obstruction Type			Storm Grate/Utility Type	
		N/A			N/A
		Yes		Surface Condition? (G/P)	Good

**Remove & Replace Curb Ramp With Two New Directional Ramps or Equivalent.**
