Access Compliance Report

Public Rights-of-Way

(Curb Ramps)

Intersection ID: 24872	Main Street: CARMEL_RD	Cross Street: GLEN_FOREST_DR	Location: NW
ADA ID: F8073C0E56AA	Ramp Type: PerpDiag	Initial Pass/Fail: Fail	Overall Compliance: No
		Severity Score: 22.5

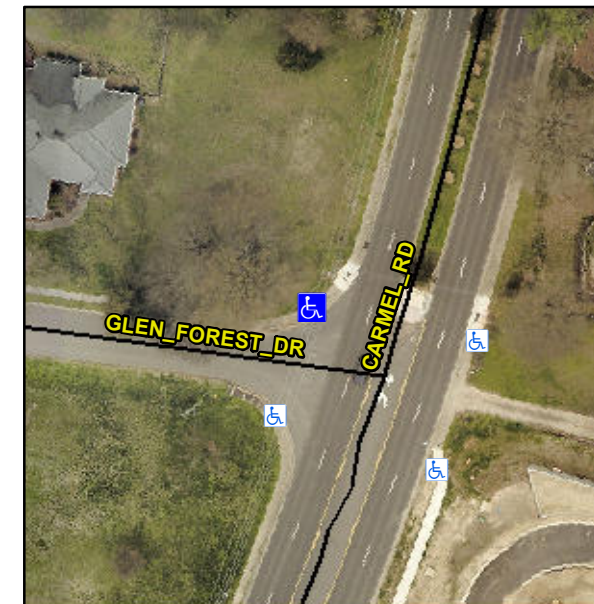
Compliance	Description	Data	Compliance	Description	Data
N/A	Ramp Length (in)	60.0	No	Ramp Slope (%)	8.6
No	Ramp Width (in)	46.0	No	Ramp XSlope (%)	2.3
N/A	Flare Type LT	N/A	N/A	Flare Type RT	N/A
N/A	Flare Slope LT (%)	N/A	N/A	Flare Slope RT (%)	N/A
N/A	Flare Traversable LT?	N/A	N/A	Flare Traversable RT?	N/A
N/A	Landing Length (in)	N/A	N/A	DWS Provided?	N/A
N/A	Landing Width (in)	N/A	N/A	DWS Contrast?	N/A
N/A	Landing Slope (%)	N/A	N/A	DWS Length (in)	N/A
N/A	Landing X Slope (%)	N/A	N/A	DWS Full Width?	N/A
N/A	Landing Curb? (Y/N)	N/A	N/A	DWS Offset (in)	N/A
N/A	Shared Landing?	N/A			
N/A	Gutter Ponding?	N/A	N/A	Gutter Slope (%)	N/A
N/A	Gutter Lip Ht (in)	N/A	N/A	Gutter X Slope (%)	N/A
N/A	Painted X Walk1?	No	N/A	Painted X Walk2?	No
	X Walk 1 Direction	To SW		X Walk 2 Direction	To SE
N/A	X Walk 1 Width (in)	N/A	N/A	X Walk 2 Width (in)	N/A
	X Walk 1 Slope (%)	1.8		X Walk 2 Slope (%)	2.2
	X Walk 1 X Slope (%)	2.1		X Walk 2 X Slope (%)	2.6

N/A	Ramp inside XWalk1?	N/A	N/A	Ramp inside XWalk2?	N/A
	Road Slope (%)	2.1	N/A	Clear Space?	N/A
	Road X Slope (%)	1.5	N/A	Clear Space to XWalk (in)	N/A
N/A	Any Obstructions?	N/A	N/A	Storm Grate/Utility Hazard?	N/A
	Obstruction Type			Storm Grate/Utility Type	
		N/A			N/A
			Yes	Surface Condition? (G/P)	Good

Remove & Replace Curb Ramp With Two New Directional Ramps or Equivalent.
