Access Compliance Report

Public Rights-of-Way (Curb Ramps)

Intersection ID: 8749	Main Street: BARRINGTON_DR	Cross Street: OLD_COACH_RD	Location: W
ADA ID: F808B0A63EEB	Ramp Type: Directional1	Initial Pass/Fail: Fail	Overall Compliance: No
		Severity Score: 10

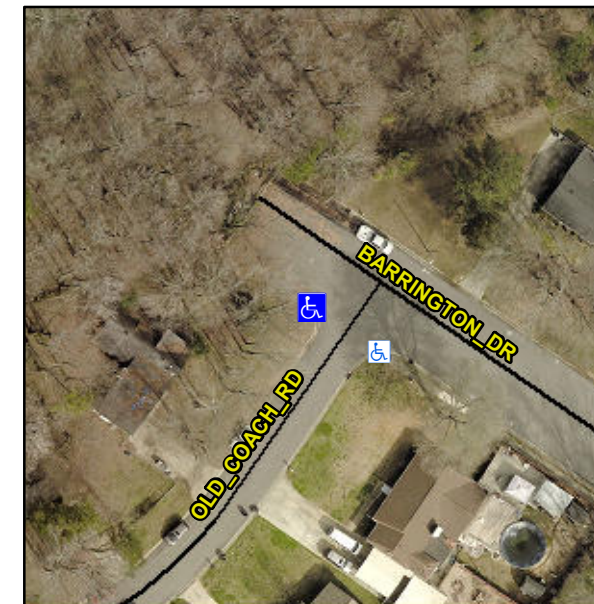
DAMAGED SURFACE

Compliance	Description	Data	Compliance	Description	Data
N/A	Ramp Length (in)	84.0	N/A	Grade Break?	N/A
No	Ramp Width (in)	47.0	N/A	Grade Break Slope (%)	0.0
Yes	Ramp Slope (%)	5.1	N/A	Grade Break XSlope (%)	0.0
No	Ramp XSlope (%)	4.2			
N/A	Flare Type LT	N/A	N/A	Flare Type RT	N/A
N/A	Flare Slope LT (%)	N/A	N/A	Flare Slope RT (%)	0.0
N/A	Flare Traversable LT?	N/A	N/A	Flare Traversable RT?	N/A
N/A	Landing Length (in)	0.0	N/A	DWS Provided?	N/A
N/A	Landing Width (in)	0.0	N/A	DWS Contrast?	N/A
N/A	Landing Slope (%)	0.0	N/A	DWS Length (in)	N/A
N/A	Landing X Slope (%)	0.0	N/A	DWS Full Width?	N/A
N/A	Landing Curb? (Y/N)	N/A	N/A	DWS Offset LT (in)	N/A
N/A	Shared Landing?	N/A	N/A	DWS Offset RT (in)	N/A
N/A	Gutter Ponding?	0.0	N/A	Gutter Slope (%)	N/A
N/A	Gutter Lip Ht (in)	1.5	N/A	Gutter X Slope (%)	N/A
N/A	Painted X Walk1?	No		Road Slope (%)	0.3
	X Walk 1 Direction	To SE		Road X Slope (%)	4.2
	X Walk 1 Width (in)	N/A		Clear Space?	N/A

X Walk 1 Slope (%)	0.3	N/A	Clear Space to XWalk (in)	N/A
	X Walk 1 X Slope (%)	4.2	N/A	Storm Grate/Utility Hazard?	N/A
N/A	Ramp inside XWalk1?	N/A		Storm Grate/Utility Type	
N/A	Any Obstructions?	N/A			N/A
	Obstruction Type		Yes	Surface Condition? (G/P)	Good
			N/A	Curb Slope (%)	9.2

Remove & Replace Entire Ramp.
