| Intersection ID: 11484 | Main Street: FLAMINGO_AV | Cross Street: HILLIARD_DR | Location: | NE |
| ADA ID: F808B8254E2F | Ramp Type: Perp | Initial Pass/Fail: Fail | Overall Compliance: No | Severity Score: 8.75 |

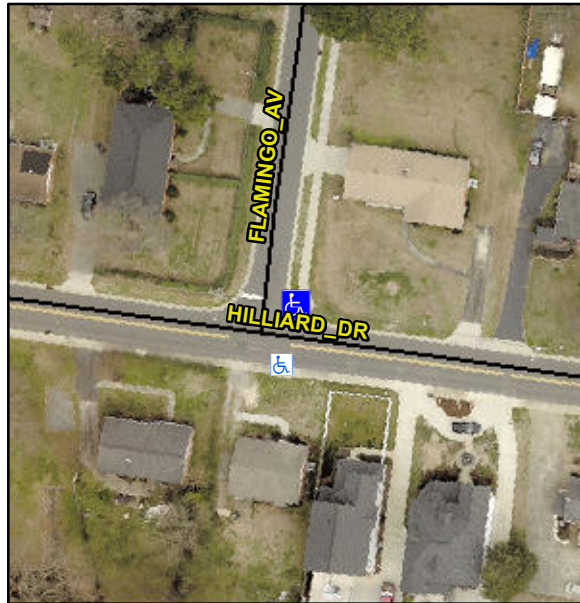
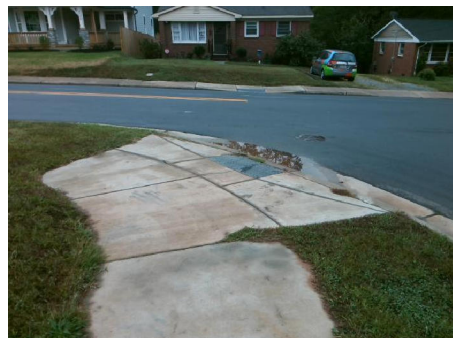
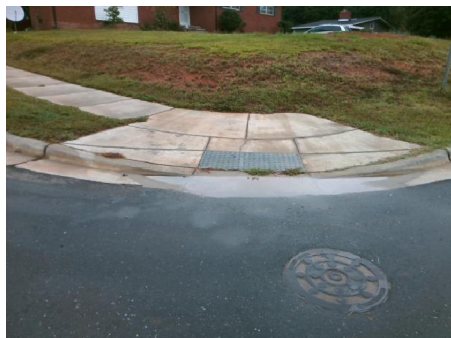
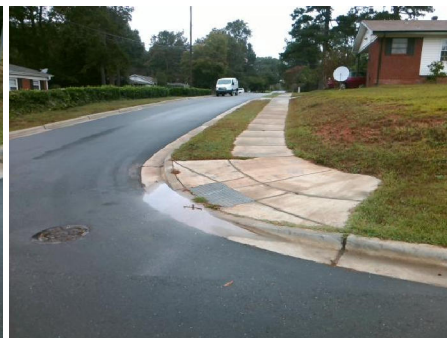
Not Found, R304.5.1

| Compliance | Description | Data | Compliance | Description | Data |
|---|---|---|---|---|---|
| No | Ramp Width (in) | 47.5 | Yes | Ramp XSlope (%) | 1.6 |
| N/A | Gutter Ponding? | Yes | N/A | Gutter Slope (%) | N/A |

Remove & Replace Entire Ramp.

Total Cost: \$ 1850.00
