Access Compliance Report

Public Rights-of-Way

(Curb Ramps)

Intersection ID: 17685	Main Street: MORGENSE_PL	Cross Street: REDSTONES_RD	Location: NW
ADA ID: F818173D20CD	Ramp Type: PerpDiag	Initial Pass/Fail: Fail	Overall Compliance: No
		Severity Score: 25

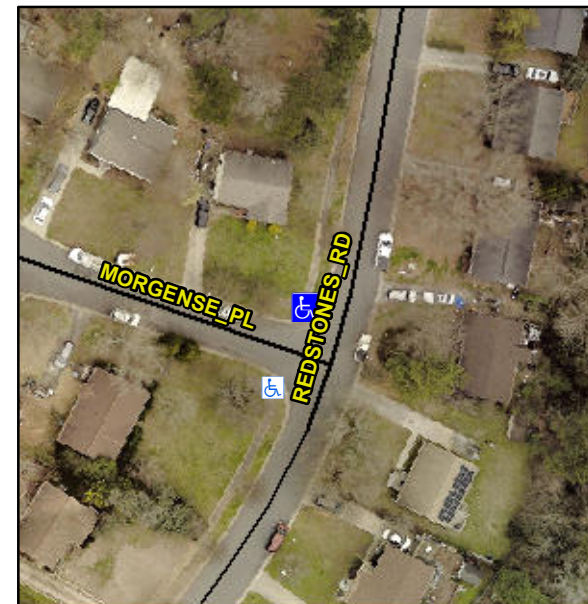
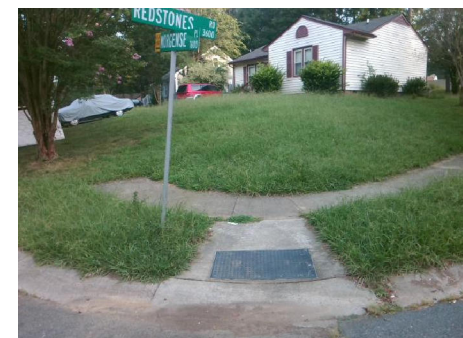
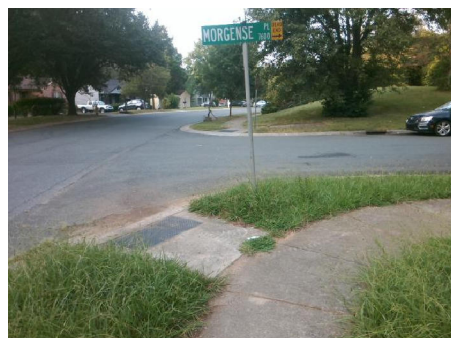
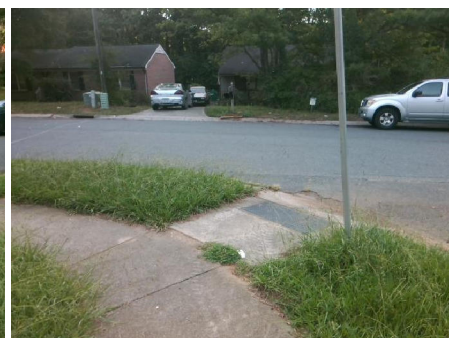
Not Found, R304.2.2

Compliance	Description	Data	Compliance	Description	Data
N/A	Ramp Length (in)	70.0	No	Ramp Slope (%)	14.2
Yes	Ramp Width (in)	48.0	Yes	Ramp XSlope (%)	0.7
N/A	Flare Type LT	N/A	N/A	Flare Type RT	N/A
N/A	Flare Slope LT (%)	N/A	N/A	Flare Slope RT (%)	N/A
N/A	Flare Traversable LT?	N/A	N/A	Flare Traversable RT?	N/A
N/A	Landing Length (in)	N/A	N/A	DWS Provided?	N/A
N/A	Landing Width (in)	N/A	N/A	DWS Contrast?	N/A
N/A	Landing Slope (%)	N/A	N/A	DWS Length (in)	N/A
N/A	Landing X Slope (%)	N/A	N/A	DWS Full Width?	N/A
N/A	Landing Curb? (Y/N)	N/A	N/A	DWS Offset (in)	N/A
N/A	Shared Landing?	N/A			
N/A	Gutter Ponding?	N/A	N/A	Gutter Slope (%)	N/A
N/A	Gutter Lip Ht (in)	N/A	N/A	Gutter X Slope (%)	N/A
N/A	Painted X Walk1?	No	N/A	Painted X Walk2?	No
	X Walk 1 Direction	To SW		X Walk 2 Direction	To SE
N/A	X Walk 1 Width (in)	N/A	N/A	X Walk 2 Width (in)	N/A
	X Walk 1 Slope (%)	1.7		X Walk 2 Slope (%)	3.7
	X Walk 1 X Slope (%)	0.4		X Walk 2 X Slope (%)	1.1

Remove & Replace Curb Ramp With Two New Directional Ramps or Equivalent.
