# Access Compliance Report

## Public Rights-of-Way

### (Curb Ramps)

Intersection ID: 27452	Main Street: BALLANTYNE COMMONS PY	Cross Street: BALLANTYNE CORPORATE PL	Location: NW
ADA ID: F819A02C9E30	Ramp Type: Directional1	Initial Pass/Fail: Fail	Overall Compliance: No
Severity Score: 8.75			
Codes/Mitigation Info/Possible Solution		Field Measurements/Component Compliance

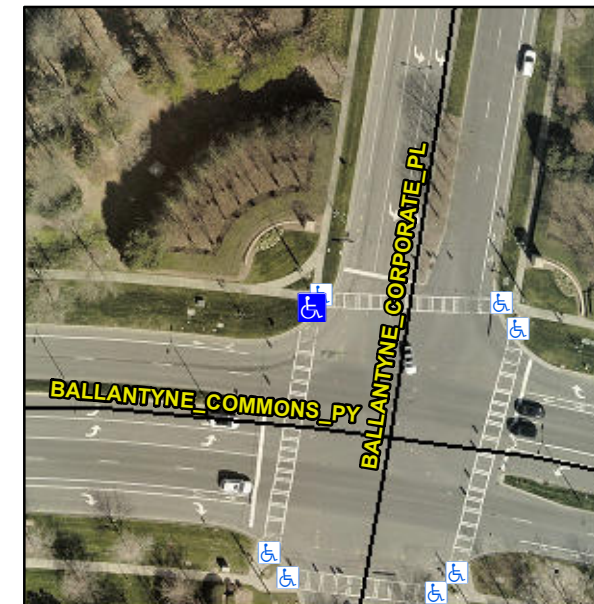
Compliance	Description	Data	Compliance	Description	Data
N/A	Ramp Length (in)	40.0	N/A	Grade Break?	N/A
No	Ramp Width (in)	46.0	N/A	Grade Break Slope (%)	0.0
Yes	Ramp Slope (%)	6.7	N/A	Grade Break XSlope (%)	0.0
Yes	Ramp XSlope (%)	0.5			
N/A	Flare Type LT	N/A	N/A	Flare Type RT	N/A
N/A	Flare Slope LT (%)	N/A	N/A	Flare Slope RT (%)	0.0
N/A	Flare Traversable LT?	N/A	N/A	Flare Traversable RT?	N/A
N/A	Landing Length (in)	0.0	N/A	DWS Provided?	N/A
N/A	Landing Width (in)	0.0	N/A	DWS Contrast?	N/A
N/A	Landing Slope (%)	0.0	N/A	DWS Length (in)	N/A
N/A	Landing X Slope (%)	0.0	N/A	DWS Full Width?	N/A
N/A	Landing Curb? (Y/N)	N/A	N/A	DWS Offset LT (in)	N/A
N/A	Shared Landing?	N/A	N/A	DWS Offset RT (in)	N/A
N/A	Gutter Ponding?	0.0	N/A	Gutter Slope (%)	N/A
N/A	Gutter Lip Ht (in)	0.0	N/A	Gutter X Slope (%)	N/A
N/A	Painted X Walk1?	Yes		Road Slope (%)	5.4
	X Walk 1 Direction	To S		Road X Slope (%)	3.5
	X Walk 1 Width (in)	110.0		Clear Space?	N/A

X Walk 1 Slope (%)	5.4	N/A	Clear Space to XWalk (in)	N/A
	X Walk 1 X Slope (%)	3.5	N/A	Storm Grate/Utility Hazard?	N/A
N/A	Ramp inside XWalk1?	Yes		Storm Grate/Utility Type	
N/A	Any Obstructions?	N/A			N/A
	Obstruction Type		Yes	Surface Condition? (G/P)	Good
			N/A	Curb Slope (%)	10.2

Possible Solutions:

**Remove & Replace Entire Ramp.**

**R304.5.1**

\$ 1600.00
