Access Compliance Report Public Rights-of-Way (Curb Ramps)

Intersection ID: 9911	Main Str	Stroot.				Location:	SW		
	Main Street: BURTON_ST			Cross Street: DOUBLE_OAKS_RD					
ADA ID: F81E34E251C0	C0 Ramp Type: PerpDiag			Initial Pass/Fail: Fail Overall Compliance: No				o Severity Score:	37.5
Codes/Mitigation Info/Possible Solution				Field Measurements/Component Compliance					
		Possible Solutions:		Compliance Description			Data Compliance Description		
The second		Remove & Replace Curb Ramp V	Nith	N/A	Ramp Length (in)	58.0	No	Ramp Slope (%)	13.0
		Two New Directional Ramps or		Yes	Ramp Width (in)	48.0	No	Ramp XSlope (%)	5.2
The second second	9 North Star	Equivalent.		N/A	Flare Type LT	N/A	N/A	Flare Type RT	N/A

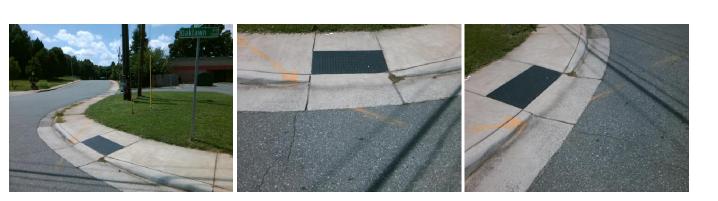
e.				N/A	Flare Slope LT (%)	N/A	N/A	Flare Slope RT (%)	N/A
OAKILAWN AV				N/A	Flare Traversable LT?	N/A	N/A	Flare Traversable RT?	N/A
A TO TO				N/A	Landing Length (in)	N/A	N/A	DWS Provided?	N/A
A BE MY	1	Surveyor Notes:		N/A	Landing Width (in)	N/A	N/A	DWS Contrast?	N/A
et la	my who	N/A		N/A	Landing Slope (%)	N/A	N/A	DWS Length (in)	N/A
a second the second sec	the second			N/A	Landing X Slope (%)	N/A	N/A	DWS Full Width?	N/A
	1			N/A	Landing Curb? (Y/N)	N/A	N/A	DWS Offset (in)	N/A
	100000	1		N/A	Shared Landing?	N/A			
	1 - marting Sand	PROW/ADA:		N/A	Gutter Ponding?	N/A	N/A	Gutter Slope (%)	N/A
	14 Nauto	Not Found, R304.2.2, R304.5.3		N/A	Gutter Lip Ht (in)	N/A	N/A	Gutter X Slope (%)	N/A

N. SAMA			N/A	Painted X Walk1?	No	N/A	Painted X Walk2?	No
the second as 19	1				X Walk 1 Direction	To SE		X Walk 2 Direction	To N
the second with	- 377 A.			N/A	X Walk 1 Width (in)	N/A	N/A	X Walk 2 Width (in)	N/A
Street 1 Name	BURTON ST				X Walk 1 Slope (%)	7.6		X Walk 2 Slope (%)	4.4
Stop Condition-Street 2	StopSign				X Walk 1 X Slope (%)	1.6		X Walk 2 X Slope (%)	4.0
Street 2 Name	OAKLAWN AV			N/A	Ramp inside XWalk1?	N/A	N/A	Ramp inside XWalk2?	N/A
Stop Condition-Street 1	None				Road Slope (%)	2.8	N/A	Clear Space?	N/A
					Road X Slope (%)	6.4	N/A	Clear Space to XWalk (in)	N/A
				N/A	Any Obstructions?	N/A	N/A	Storm Grate/Utility Hazard?	N/A
		Total Cost: \$ 3	3200.00		Obstruction Type			Storm Grate/Utility Type	
						N/A			N/A
