| Intersection ID: 9530 | Main Street: MCBRIDE_ST | Cross Street: THE_PLAZA | Location: | S |
| ADA ID: F81EFDC909C8 | Ramp Type: PerpDiag | Initial Pass/Fail: Pass | Overall Compliance: No | Severity Score: 27.75 |

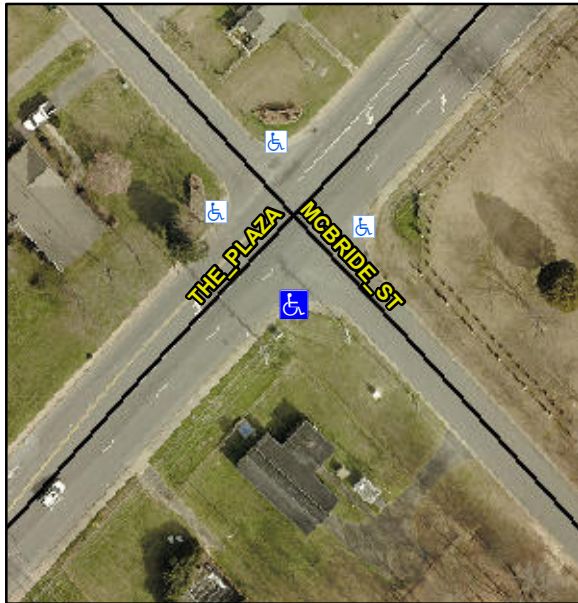
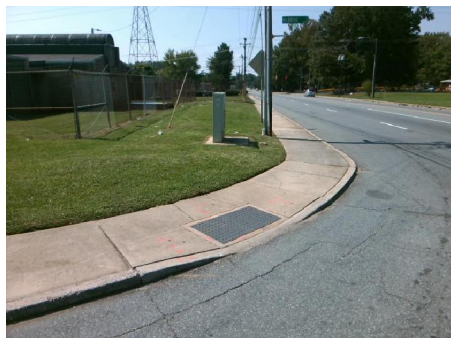
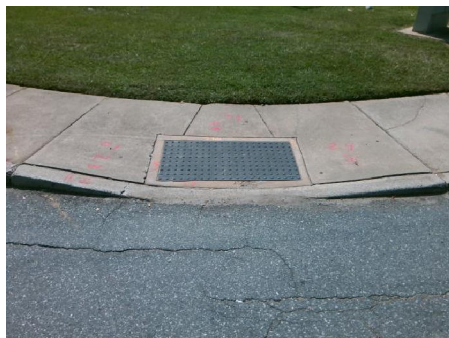
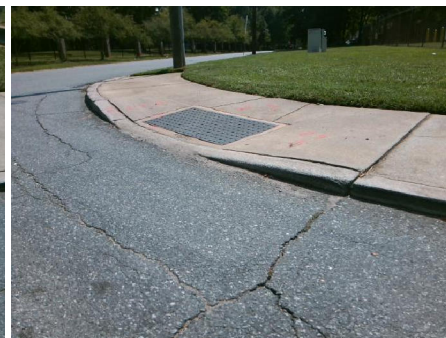
Not Found, R304.5.3, R304.2.1,  
R304.2.2-Perp, R304.3.2-Para,  
R304.2.3, R305.1.4, R305.2, R302.7,

| Compliance | Description | Data | Compliance | Description | Data |
|---|---|---|---|---|---|
| Yes | Ramp Width (in) | 54.0 | No | Ramp XSlope (%) | 4.9 |
| No | Landing X Slope (%) | N/A | No | DWS Full Width? | No |
| N/A | Landing Curb? (Y/N) | No | No | DWS Offset (in) | 5.0 |
| No | Gutter Ponding? | Yes | No | Gutter Slope (%) | 7.4 |
| No | Gutter Lip Ht (in) | 0.5 | Yes | Gutter X Slope (%) | 1.9 |

**Remove & Replace Curb Ramp With Two New Directional Ramps or Equivalent. Remove & Replace Gutter.**

**Total Cost: \$ 3950.00**
