# Access Compliance Report

## Public Rights-of-Way

| Intersection ID: 6218 | Main Street: BEAM_LAKE_DR | Cross Street: PEACHWOOD_DR | Location: SW |
| ADA ID: F82CEBAFC3E7 | Ramp Type: PerpDiag | Initial Pass/Fail: Fail | Overall Compliance: No |

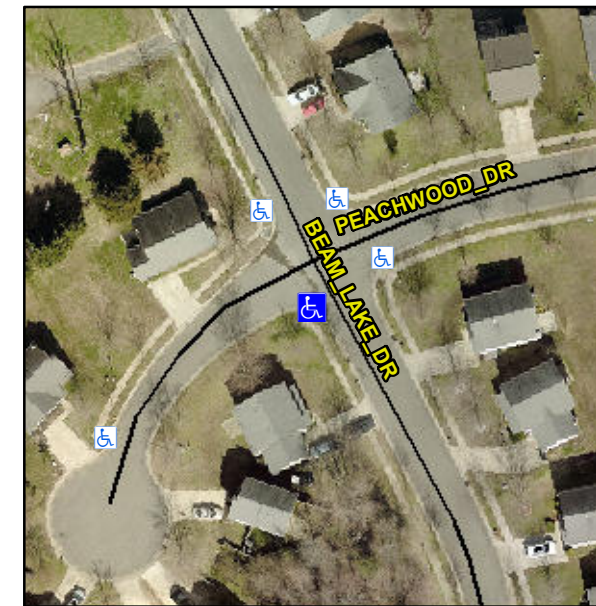
| Severity Score: 36.25 | | | |

**Not Found, R304.5.1, R304.5.3**

| Compliance | Description | Data | Compliance | Description | Data |
|---|---|---|---|---|---|
| N/A | Ramp Length (in) | 47.0 | Yes | Ramp Slope (%) | 7.4 |
| No | Ramp Width (in) | 26.0 | No | Ramp XSlope (%) | 3.0 |

**Remove & Replace Curb Ramp With Two New Directional Ramps or Equivalent.**

Total Cost: \$ 3200.00

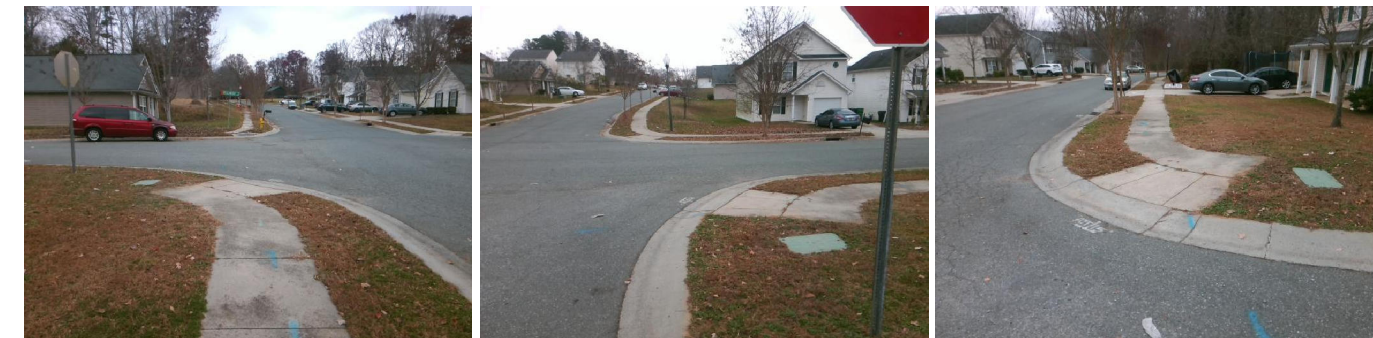
Street 1 Name **BEAM LAKE DR**  
 Stop Condition-Street 2 **None**  
 Street 2 Name **PEACHWOOD DR**  
 Stop Condition-Street 1 **StopSign**
