# Access Compliance Report

## Public Rights-of-Way

### (Curb Ramps)

Intersection ID: 11295	Main Street: AVENTIDE_LN	Cross Street: CHANTRESS_LN	Location: SE
ADA ID: F82F9557C687	Ramp Type: Perp	Initial Pass/Fail: Fail	Overall Compliance: No
Severity Score: 46.25			
Codes/Mitigation Info/Possible Solution		Field Measurements/Component Compliance

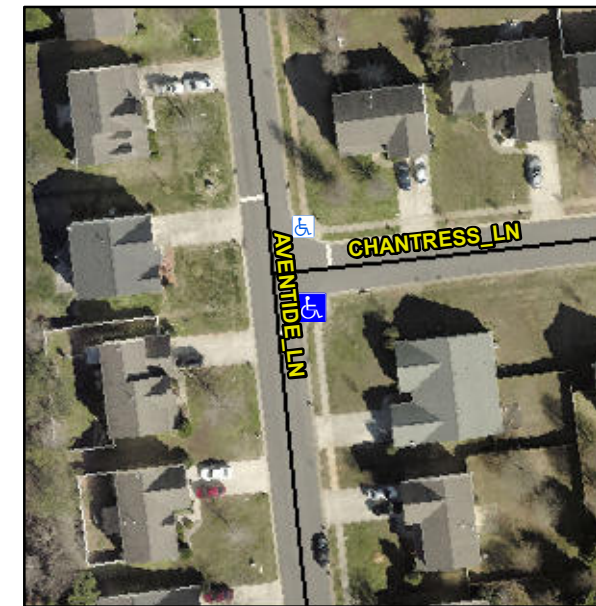
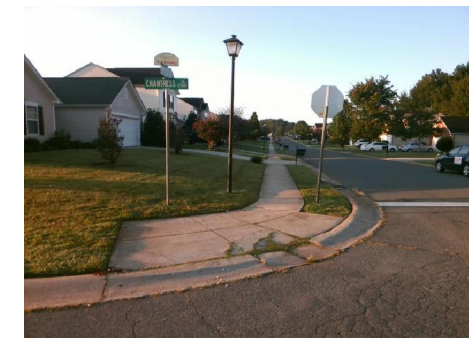
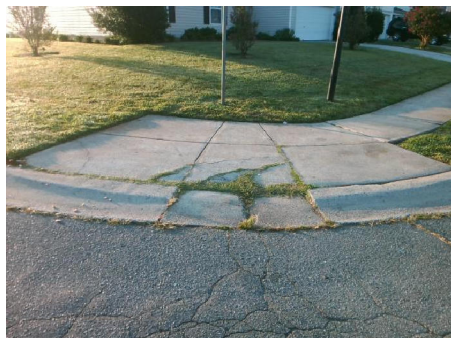
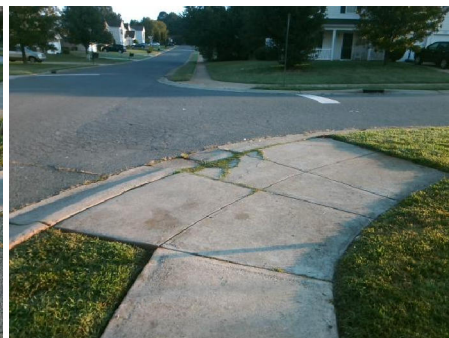
**Not Found, R304.5.1, R304.2.2, R304.5.3, R302.7**

Compliance	Description	Data	Compliance	Description	Data
N/A	Ramp Length (in)	48.0	No	Ramp Slope (%)	9.7
No	Ramp Width (in)	33.5	No	Ramp XSlope (%)	3.2
N/A	Flare Type LT	N/A	N/A	Flare Type RT	N/A
N/A	Flare Slope LT (%)	N/A	N/A	Flare Slope RT (%)	N/A
N/A	Flare Traversable LT?	N/A	N/A	Flare Traversable RT?	N/A
N/A	Landing Length (in)	N/A	N/A	DWS Provided?	N/A
N/A	Landing Width (in)	N/A	N/A	DWS Contrast?	N/A
N/A	Landing Slope (%)	N/A	N/A	DWS Length (in)	N/A
N/A	Landing X Slope (%)	N/A	N/A	DWS Full Width?	N/A
N/A	Landing Curb? (Y/N)	N/A	N/A	DWS Offset (in)	N/A
N/A	Shared Landing?	N/A			
N/A	Gutter Ponding?	N/A	N/A	Gutter Slope (%)	N/A
N/A	Gutter Lip Ht (in)	N/A	N/A	Gutter X Slope (%)	N/A
N/A	Painted X Walk1?	No	N/A	Painted X Walk2?	N/A
	X Walk 1 Direction	To N		X Walk 2 Direction	N/A
N/A	X Walk 1 Width (in)	N/A	N/A	X Walk 2 Width (in)	N/A
	X Walk 1 Slope (%)	1.3		X Walk 2 Slope (%)	N/A
	X Walk 1 X Slope (%)	0.6		X Walk 2 X Slope (%)	N/A

N/A	Ramp inside XWalk1?	N/A	N/A	Ramp inside XWalk2?	N/A
	Road Slope (%)	N/A	N/A	Clear Space?	N/A
	Road X Slope (%)	N/A	N/A	Clear Space to XWalk (in)	N/A
N/A	Any Obstructions?	N/A	N/A	Storm Grate/Utility Hazard?	N/A
	Obstruction Type			Storm Grate/Utility Type	
		N/A			N/A
		No		Surface Condition? (G/P)	Poor

**Remove & Replace Entire Ramp.**
