# Access Compliance Report

## Public Rights-of-Way (Curb Ramps)

| Intersection ID: 25776 | Main Street: CARMEL_COMMONS_BV | Cross Street: PINEVILLE-MATTHEWS_RD | Location: SE |
| ADA ID: F84C4E1B6DBA | Ramp Type: IslandPerp | Initial Pass/Fail: Fail | Overall Compliance: No |

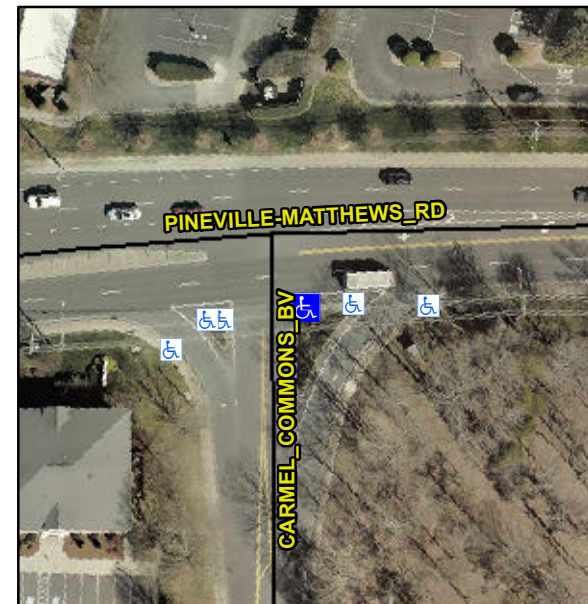
**Not Found, R304.5.1, R304.2.2**

| Compliance | Description | Data | Compliance | Description | Data |
|---|---|---|---|---|---|
| N/A | Ramp Length (in) | 65.0 | No | Ramp Slope (%) | 11.3 |
| No | Ramp Width (in) | 41.0 | Yes | Ramp XSlope (%) | 0.3 |

**Remove & Replace Entire Ramp.**
