Access Compliance Report

Public Rights-of-Way

(Curb Ramps)

Intersection ID: 10020349	Main Street: BALLANTYNE COMMONS PY	Cross Street: N/A	Location: NE
ADA ID: F84D7C55849E	Ramp Type: Perp	Initial Pass/Fail: Fail	Overall Compliance: No
Codes/Mitigation Info/Possible Solution		Field Measurements/Component Compliance	
Severity Score: 46.25

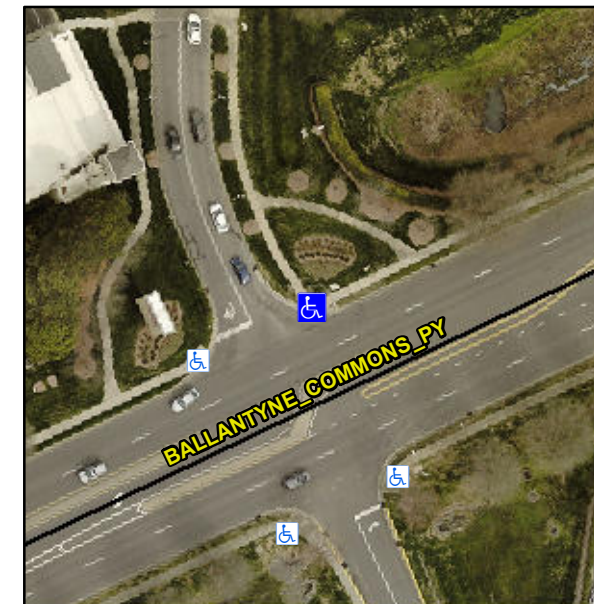
Not Found, R304.5.1, R304.2.2, R304.5.3

Compliance	Description	Data	Compliance	Description	Data
N/A	Ramp Length (in)	78.0	No	Ramp Slope (%)	8.8
No	Ramp Width (in)	43.0	No	Ramp XSlope (%)	7.3
N/A	Flare Type LT	N/A	N/A	Flare Type RT	N/A
N/A	Flare Slope LT (%)	N/A	N/A	Flare Slope RT (%)	N/A
N/A	Flare Traversable LT?	N/A	N/A	Flare Traversable RT?	N/A
N/A	Landing Length (in)	N/A	N/A	DWS Provided?	N/A
N/A	Landing Width (in)	N/A	N/A	DWS Contrast?	N/A
N/A	Landing Slope (%)	N/A	N/A	DWS Length (in)	N/A
N/A	Landing X Slope (%)	N/A	N/A	DWS Full Width?	N/A
N/A	Landing Curb? (Y/N)	N/A	N/A	DWS Offset (in)	N/A
N/A	Shared Landing?	N/A			
N/A	Gutter Ponding?	N/A	N/A	Gutter Slope (%)	N/A
N/A	Gutter Lip Ht (in)	N/A	N/A	Gutter X Slope (%)	N/A
N/A	Painted X Walk1?	No	N/A	Painted X Walk2?	N/A
	X Walk 1 Direction	To W		X Walk 2 Direction	N/A
N/A	X Walk 1 Width (in)	N/A	N/A	X Walk 2 Width (in)	N/A
	X Walk 1 Slope (%)	3.6		X Walk 2 Slope (%)	N/A
	X Walk 1 X Slope (%)	3.7		X Walk 2 X Slope (%)	N/A

N/A	Ramp inside XWalk1?	N/A	N/A	Ramp inside XWalk2?	N/A
	Road Slope (%)	N/A	N/A	Clear Space?	N/A
	Road X Slope (%)	N/A	N/A	Clear Space to XWalk (in)	N/A
N/A	Any Obstructions?	N/A	N/A	Storm Grate/Utility Hazard?	N/A
	Obstruction Type			Storm Grate/Utility Type	
		N/A			N/A
			Yes	Surface Condition? (G/P)	Good

Remove & Replace Entire Ramp.
