# Access Compliance Report

## Public Rights-of-Way

### (Curb Ramps)

Intersection ID: 9610	Main Street: BARRINGTON_DR	Cross Street: THE_PLAZA	Location: SE
ADA ID: F85677DA9287	Ramp Type: ParaDiag	Initial Pass/Fail: Pass	Overall Compliance: No
Codes/Mitigation Info/Possible Solution		Field Measurements/Component Compliance	
Severity Score: 7.75

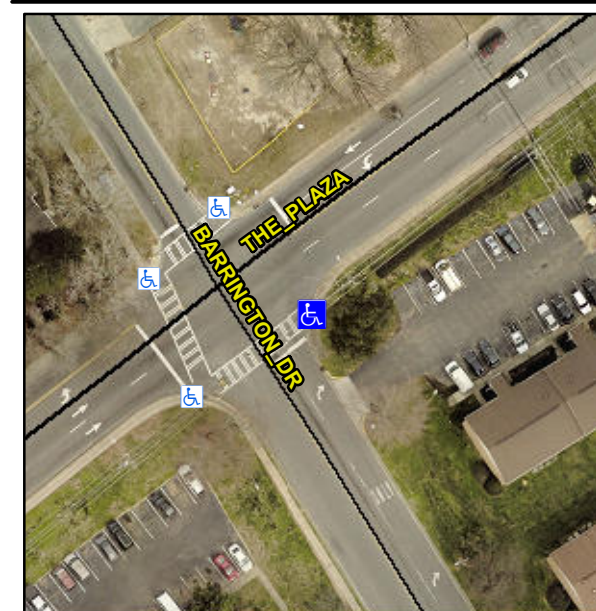
Compliance	Description	Data	Compliance	Description	Data
N/A	Ramp Length LT (in)	48.0	N/A	Ramp Length RT (in)	37.0
Yes	Ramp Width LT (in)	60.0	Yes	Ramp Width RT (in)	58.0
Yes	Ramp Slope LT (%)	5.6	Yes	Ramp Slope RT (%)	6.2
Yes	Ramp XSlope LT (%)	0.2	No	Ramp XSlope RT (%)	2.8
Yes	Landing Length (in)	60.0	Yes	DWS Provided?	Yes
No	Landing Width (in)	34.0	Yes	DWS Contrast?	Yes
No	Landing Slope (%)	4.5	Yes	DWS Length (in)	25.5
No	Landing X Slope (%)	2.7	Yes	DWS Full Width?	Yes
N/A	Landing Curb? (Y/N)	No	No	DWS Offset (in)	4.0
N/A	Shared Landing?	No			
No	Gutter Ponding?	Yes	Yes	Gutter Slope (%)	4.1
No	Gutter Lip Ht (in)	0.5	Yes	Gutter X Slope (%)	2.0
N/A	Painted X Walk1?	No	N/A	Painted X Walk2?	Yes
	X Walk 1 Direction	To NW		X Walk 2 Direction	To SW
N/A	X Walk 1 Width (in)	N/A	N/A	X Walk 2 Width (in)	106.0
	X Walk 1 Slope (%)	1.5		X Walk 2 Slope (%)	2.0
	X Walk 1 X Slope (%)	2.5		X Walk 2 X Slope (%)	0.2
N/A	Ramp inside XWalk1?	N/A	Yes	Ramp inside XWalk2?	Yes

Road Slope (%)	0.7	N/A	Clear Space?	Yes
	Road X Slope (%)	1.8	N/A	Clear Space to XWalk (in)	N/A
Yes	Any Obstructions?	No	Yes	Storm Grate/Utility Hazard?	No
	Obstruction Type			Storm Grate/Utility Type	
		N/A			N/A
			Yes	Surface Condition? (G/P)	Good
			N/A	Curb Slope (%)	9.4

Possible Solutions:

**Remove & Replace Curb Ramp With Two New Directional Ramps or Equivalent. Grind Gutter Lip.**
