Access Compliance Report

Public Rights-of-Way

(Curb Ramps)

Intersection ID: 20567	Main Street: PARK_SOUTH_DR	Cross Street: PINE_VALLEY_RD	Location: SE
ADA ID: F86B65F156DF	Ramp Type: PerpDiag	Initial Pass/Fail: Fail	Overall Compliance: No
			Severity Score: 21.25

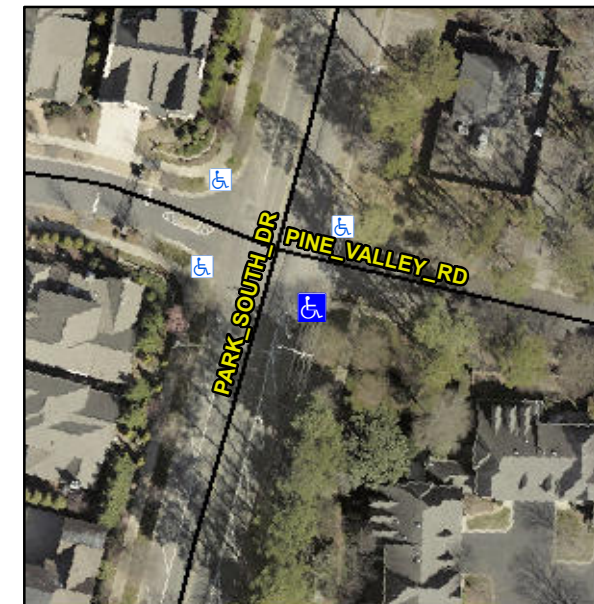
Compliance	Description	Data	Compliance	Description	Data
N/A	Ramp Length (in)	84.0	Yes	Ramp Slope (%)	7.6
No	Ramp Width (in)	40.0	No	Ramp XSlope (%)	5.9
N/A	Flare Type LT	N/A	N/A	Flare Type RT	N/A
N/A	Flare Slope LT (%)	N/A	N/A	Flare Slope RT (%)	N/A
N/A	Flare Traversable LT?	N/A	N/A	Flare Traversable RT?	N/A
N/A	Landing Length (in)	N/A	N/A	DWS Provided?	N/A
N/A	Landing Width (in)	N/A	N/A	DWS Contrast?	N/A
N/A	Landing Slope (%)	N/A	N/A	DWS Length (in)	N/A
N/A	Landing X Slope (%)	N/A	N/A	DWS Full Width?	N/A
N/A	Landing Curb? (Y/N)	N/A	N/A	DWS Offset (in)	N/A
N/A	Shared Landing?	N/A			
N/A	Gutter Ponding?	Yes	N/A	Gutter Slope (%)	N/A
N/A	Gutter Lip Ht (in)	0.5	N/A	Gutter X Slope (%)	N/A
N/A	Painted X Walk1?	No	N/A	Painted X Walk2?	No
	X Walk 1 Direction	To NE		X Walk 2 Direction	To NW
N/A	X Walk 1 Width (in)	N/A	N/A	X Walk 2 Width (in)	N/A
	X Walk 1 Slope (%)	1.8		X Walk 2 Slope (%)	2.2
	X Walk 1 X Slope (%)	1.4		X Walk 2 X Slope (%)	0.9

N/A	Ramp inside XWalk1?	N/A	N/A	Ramp inside XWalk2?	N/A
	Road Slope (%)	1.5	N/A	Clear Space?	N/A
	Road X Slope (%)	2.2	N/A	Clear Space to XWalk (in)	N/A
N/A	Any Obstructions?	N/A	N/A	Storm Grate/Utility Hazard?	N/A
	Obstruction Type			Storm Grate/Utility Type	
		N/A			N/A
			Yes	Surface Condition? (G/P)	Good

Remove & Replace Curb Ramp With Two New Directional Ramps or Equivalent.

Not Found, R304.5.1, R304.5.3
