## **Access Compliance Report Public Rights-of-Way** (Curb Ramps)

Intersection ID: 10034961 Main Street: PROVIDENCE RD WEST **Cross Street: N/A** Location: SW ADA ID: F876526C9DE5 Ramp Type: PerpDiag Initial Pass/Fail: Fail **Overall Compliance: No Severity Score:** 22.5

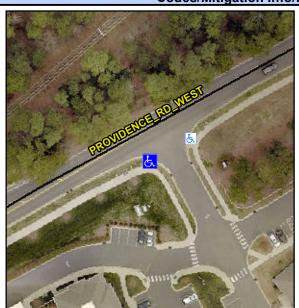
Field Measurements/Component Compliance					
Compliance Description		Data	Comp	oliance Description	Data
N/A	Ramp Length (in)	64.0	No	Ramp Slope (%)	8.6
No	Ramp Width (in)	47.0	No	Ramp XSlope (%)	4.1
N/A	Flare Type LT	N/A	N/A	Flare Type RT	N/A
N/A	Flare Slope LT (%)	N/A	N/A	Flare Slope RT (%)	N/A
N/A	Flare Traversable LT?	N/A	N/A	Flare Traversable RT?	N/A
N/A	Landing Length (in)	N/A	N/A	DWS Provided?	N/A
N/A	Landing Width (in)	N/A	N/A	DWS Contrast?	N/A
N/A	Landing Slope (%)	N/A	N/A	DWS Length (in)	N/A
N/A	Landing X Slope (%)	N/A	N/A	DWS Full Width?	N/A
N/A	Landing Curb? (Y/N)	N/A	N/A	DWS Offset (in)	N/A
N/A	Shared Landing?	N/A			
N/A	Gutter Ponding?	N/A	N/A	Gutter Slope (%)	N/A
N/A	Gutter Lip Ht (in)	N/A	N/A	Gutter X Slope (%)	N/A
N/A	Painted X Walk1?	No	N/A	Painted X Walk2?	No
	X Walk 1 Direction	To NE		X Walk 2 Direction	To N
N/A	X Walk 1 Width (in)	N/A	N/A	X Walk 2 Width (in)	N/A
	X Walk 1 Slope (%)	3.3		X Walk 2 Slope (%)	1.8

X Walk 1 X Slope (%)	1.7		X Walk 2 X Slope (%)	0.9
N/A	Ramp inside XWalk1?	N/A	N/A	Ramp inside XWalk2?	N/A
	Road Slope (%)	0.9	N/A	Clear Space?	N/A
	Road X Slope (%)	0.6	N/A	Clear Space to XWalk (in)	N/A
N/A	Any Obstructions?	N/A	N/A	Storm Grate/Utility Hazard?	N/A
	Obstruction Type			Storm Grate/Utility Type	
		N/A			N/A
			Yes	Surface Condition? (G/P)	Good
7 1 9 1			-

Possible Solutions: Remove & Replace Curb Ramp With **Two New Directional Ramps or** Equivalent. Surveyor Notes: N/A PROW/ADA: Not Found, R304.5.1, R304.2.2, R304.5.3

Total Cost: 3200.00
