# Access Compliance Report

## Public Rights-of-Way

### (Curb Ramps)

| Intersection ID: 10025569 | Main Street: E_W_T_HARRIS_BV | Cross Street: N/A | Location: NW |

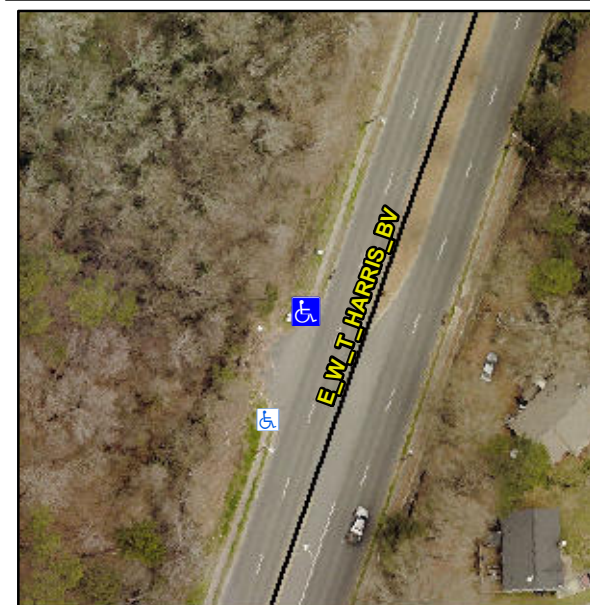
| ADA ID: F876FDF3E202 | Ramp Type: PerpDiag | Initial Pass/Fail: Fail | Overall Compliance: No |
| Severity Score: 25 | | | |

**Not Found, R304.2.2, R304.5.3**

| Compliance | Description | Data | Compliance | Description | Data |
|---|---|---|---|---|---|
| N/A | Ramp Length (in) | 68.0 | No | Ramp Slope (%) | 8.9 |
| Yes | Ramp Width (in) | 48.0 | No | Ramp XSlope (%) | 5.6 |

**Remove & Replace Curb Ramp With Two New Directional Ramps or Equivalent.**

Total Cost: \$ 3200.00

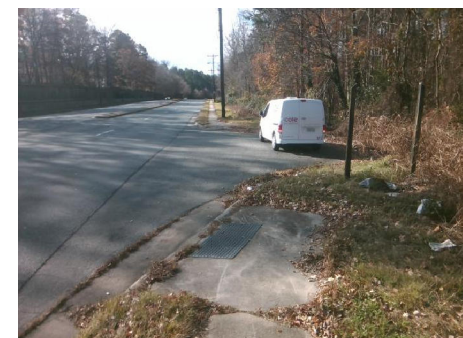
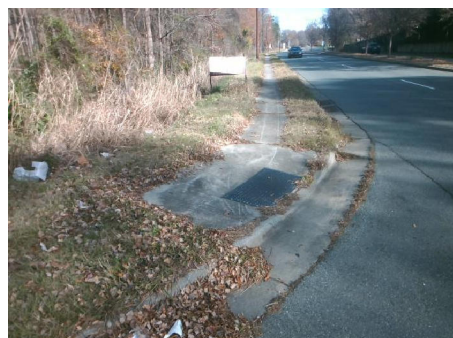
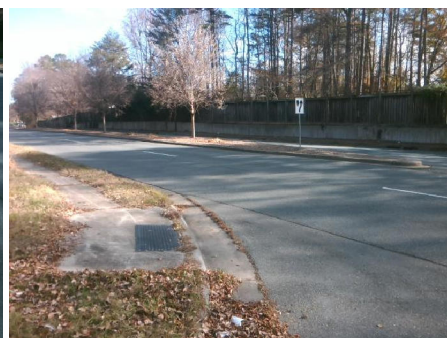
| Compliance | Description | Data | Compliance | Description | Data |
|---|---|---|---|---|---|
| | | | Yes | Surface Condition? (G/P) | Good |
