# Access Compliance Report

## Public Rights-of-Way

### (Curb Ramps)

| Intersection ID: 49387 | Main Street: SHORTHORN_ST | Cross Street: CHARBRAY_LN | Location: SW |

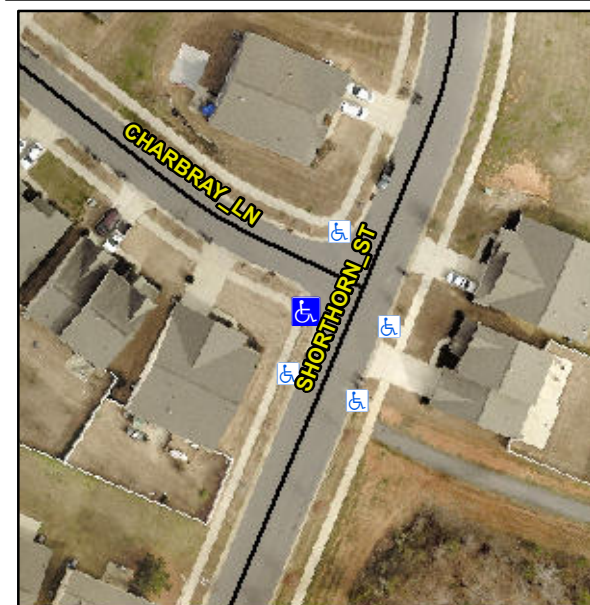
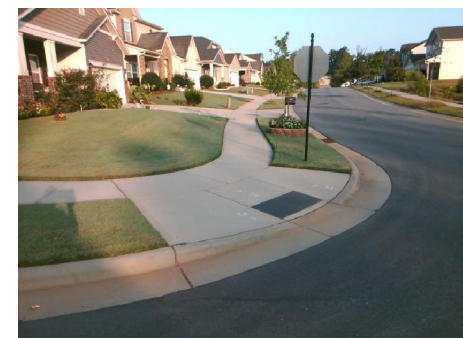
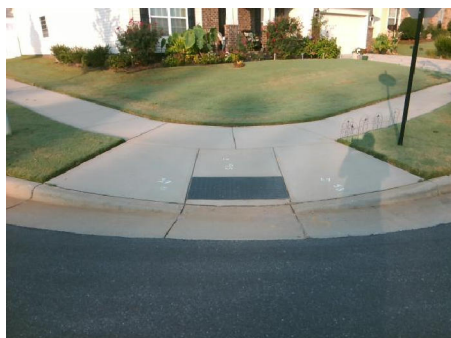
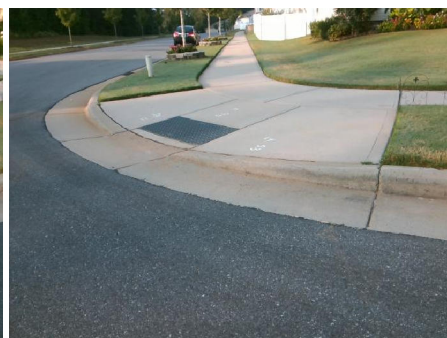
| ADA ID: F8829E76C75F | Ramp Type: PerpDiag | Initial Pass/Fail: Fail | Overall Compliance: No |

**Not Found, R304.5.1, R304.2.2**

| Compliance | Description | Data | Compliance | Description | Data |
|---|---|---|---|---|---|
| N/A | Ramp Length (in) | 71.5 | No | Ramp Slope (%) | 9.5 |
| No | Ramp Width (in) | 46.5 | Yes | Ramp XSlope (%) | 1.4 |

**Remove & Replace Curb Ramp With Two New Directional Ramps or Equivalent.**

Total Cost: \$ **3200.00**
