# Access Compliance Report

## Public Rights-of-Way

### (Curb Ramps)

| Intersection ID: 15833 | Main Street: SOUTH_BV | Cross Street: CLANTON_RD | Location: SE |

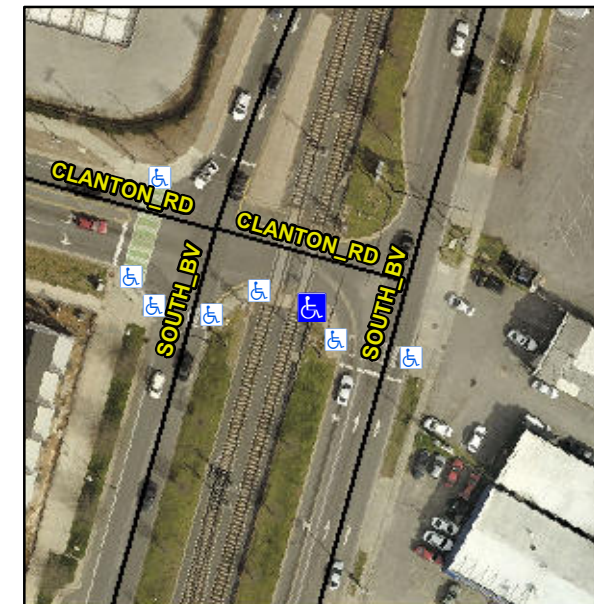
| ADA ID: F882B5CBF135 | Ramp Type: Perp | Initial Pass/Fail: Fail | Overall Compliance: No |
| | | Severity Score: 12.5 | |

| Compliance | Description | Data | Compliance | Description | Data |
|---|---|---|---|---|---|
| N/A | Ramp Length (in) | 94.0 | No | Ramp Slope (%) | 9.4 |

**Remove & Replace Entire Ramp.**

**R304.2.2**

**\$ 1850.00**
