Access Compliance Report

Public Rights-of-Way

(Curb Ramps)

Intersection ID: 49130	Main Street: AUBURN_HILL_LN	Cross Street: WILTSHIRE_RIDGE_RD	Location: NE
ADA ID: F88FE92D558E	Ramp Type: Perp	Initial Pass/Fail: Fail	Overall Compliance: No
Severity Score: 10			
Codes/Mitigation Info/Possible Solution		Field Measurements/Component Compliance

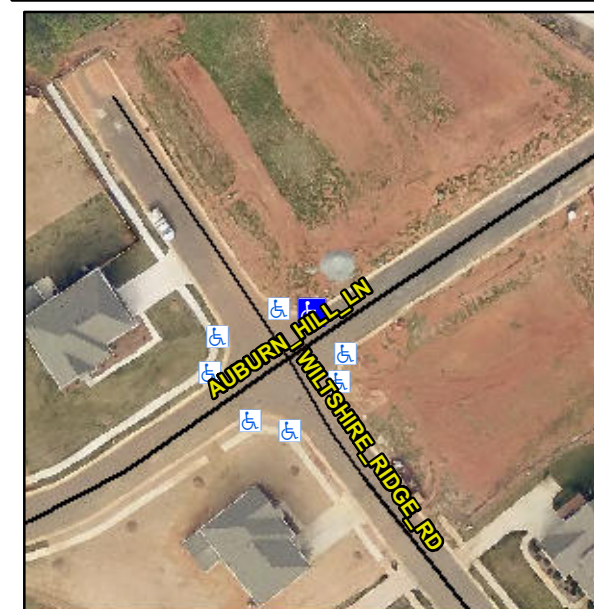
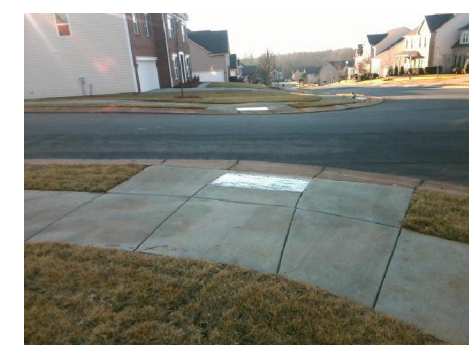
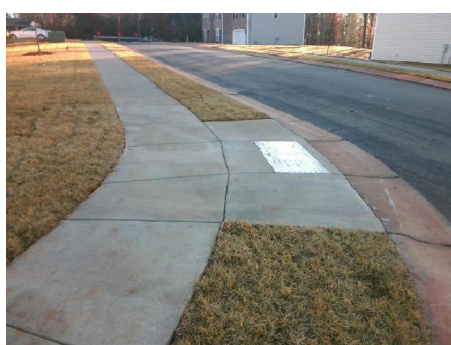
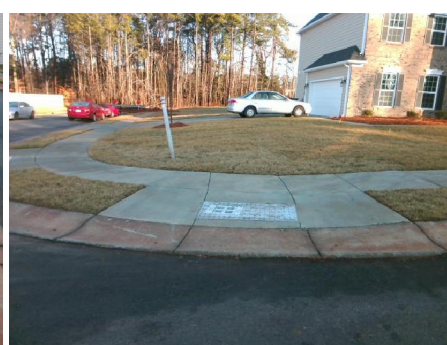
Not Found, R304.5.1

Compliance	Description	Data	Compliance	Description	Data
N/A	Ramp Length (in)	49.0	Yes	Ramp Slope (%)	5.2
No	Ramp Width (in)	47.0	Yes	Ramp XSlope (%)	2.9
N/A	Flare Type LT	N/A	N/A	Flare Type RT	N/A
N/A	Flare Slope LT (%)	N/A	N/A	Flare Slope RT (%)	N/A
N/A	Flare Traversable LT?	N/A	N/A	Flare Traversable RT?	N/A
N/A	Landing Length (in)	N/A	N/A	DWS Provided?	N/A
N/A	Landing Width (in)	N/A	N/A	DWS Contrast?	N/A
N/A	Landing Slope (%)	N/A	N/A	DWS Length (in)	N/A
N/A	Landing X Slope (%)	N/A	N/A	DWS Full Width?	N/A
N/A	Landing Curb? (Y/N)	N/A	N/A	DWS Offset (in)	N/A
N/A	Shared Landing?	N/A			
N/A	Gutter Ponding?	N/A	N/A	Gutter Slope (%)	N/A
N/A	Gutter Lip Ht (in)	N/A	N/A	Gutter X Slope (%)	N/A
N/A	Painted X Walk1?	No	N/A	Painted X Walk2?	N/A
	X Walk 1 Direction	To S		X Walk 2 Direction	N/A
N/A	X Walk 1 Width (in)	N/A	N/A	X Walk 2 Width (in)	N/A
	X Walk 1 Slope (%)	0.1		X Walk 2 Slope (%)	N/A
	X Walk 1 X Slope (%)	4.0		X Walk 2 X Slope (%)	N/A

N/A	Ramp inside XWalk1?	N/A	N/A	Ramp inside XWalk2?	N/A
	Road Slope (%)	N/A	N/A	Clear Space?	N/A
	Road X Slope (%)	N/A	N/A	Clear Space to XWalk (in)	N/A
N/A	Any Obstructions?	N/A	N/A	Storm Grate/Utility Hazard?	N/A
	Obstruction Type			Storm Grate/Utility Type	
		N/A			N/A
			Yes	Surface Condition? (G/P)	Good

Remove & Replace Entire Ramp.

Total Cost: \$ 1850.00
