Access Compliance Report

Public Rights-of-Way

(Curb Ramps)

Intersection ID: 31227	Main Street: CLACKWYCK_LN	Cross Street: HEADQUARTERS_FARM_RD	Location: E
ADA ID: F892EEEB1B18	Ramp Type: Perp	Initial Pass/Fail: Fail	Overall Compliance: No
Severity Score: 17.5			
Codes/Mitigation Info/Possible Solution		Field Measurements/Component Compliance

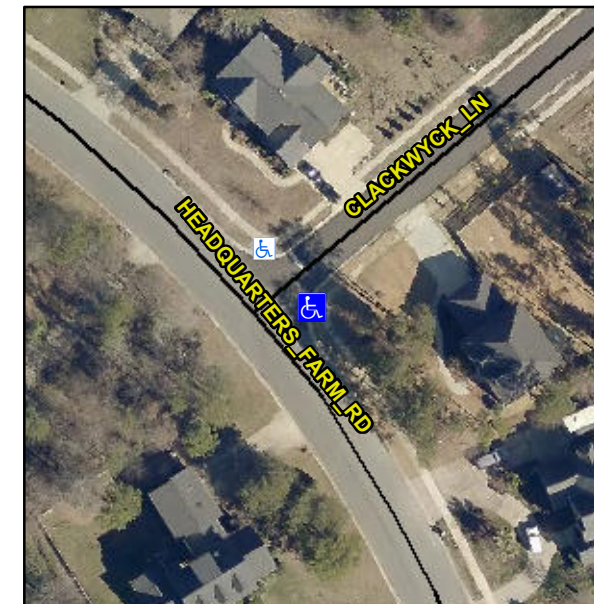
N/A

Not Found, R304.5.1

Compliance	Description	Data	Compliance	Description	Data
N/A	Ramp Length (in)	62.0	Yes	Ramp Slope (%)	5.0
No	Ramp Width (in)	35.0	Yes	Ramp XSlope (%)	0.6
N/A	Flare Type LT	N/A	N/A	Flare Type RT	N/A
N/A	Flare Slope LT (%)	N/A	N/A	Flare Slope RT (%)	N/A
N/A	Flare Traversable LT?	N/A	N/A	Flare Traversable RT?	N/A
N/A	Landing Length (in)	N/A	N/A	DWS Provided?	N/A
N/A	Landing Width (in)	N/A	N/A	DWS Contrast?	N/A
N/A	Landing Slope (%)	N/A	N/A	DWS Length (in)	N/A
N/A	Landing X Slope (%)	N/A	N/A	DWS Full Width?	N/A
N/A	Landing Curb? (Y/N)	N/A	N/A	DWS Offset (in)	N/A
N/A	Shared Landing?	N/A			
N/A	Gutter Ponding?	N/A	N/A	Gutter Slope (%)	N/A
N/A	Gutter Lip Ht (in)	N/A	N/A	Gutter X Slope (%)	N/A
N/A	Painted X Walk1?	No	N/A	Painted X Walk2?	N/A
	X Walk 1 Direction	To NW		X Walk 2 Direction	N/A
N/A	X Walk 1 Width (in)	N/A	N/A	X Walk 2 Width (in)	N/A
	X Walk 1 Slope (%)	6.1		X Walk 2 Slope (%)	N/A
	X Walk 1 X Slope (%)	1.3		X Walk 2 X Slope (%)	N/A

N/A	Ramp inside XWalk1?	N/A	N/A	Ramp inside XWalk2?	N/A
	Road Slope (%)	N/A	N/A	Clear Space?	N/A
	Road X Slope (%)	N/A	N/A	Clear Space to XWalk (in)	N/A
N/A	Any Obstructions?	N/A	N/A	Storm Grate/Utility Hazard?	N/A
	Obstruction Type			Storm Grate/Utility Type	
		N/A			N/A
		Yes		Surface Condition? (G/P)	Good

Remove & Replace Entire Ramp.

Total Cost: \$ 1850.00
