# Access Compliance Report

## Public Rights-of-Way

### (Curb Ramps)

Intersection ID: 31416	Main Street: BRAWER_FARM_DR	Cross Street: IRON_BRIGADE_LN	Location:	N
ADA ID: F89814DC980D	Ramp Type: PerpDiag	Initial Pass/Fail: Fail	Overall Compliance: No	Severity Score: 10
Codes/Mitigation Info/Possible Solution		Field Measurements/Component Compliance

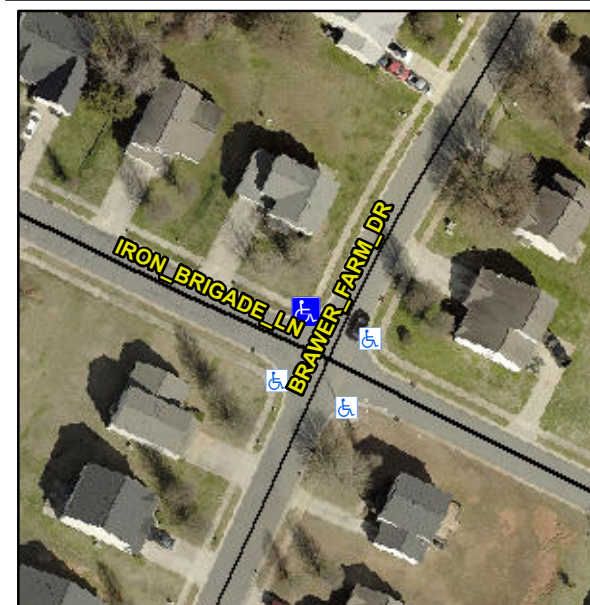
**Not Found, R304.5.1, R304.5.3**

Compliance	Description	Data	Compliance	Description	Data
N/A	Ramp Length (in)	46.0	Yes	Ramp Slope (%)	7.5
No	Ramp Width (in)	46.0	No	Ramp XSlope (%)	4.3
N/A	Flare Type LT	N/A	N/A	Flare Type RT	N/A
N/A	Flare Slope LT (%)	N/A	N/A	Flare Slope RT (%)	N/A
N/A	Flare Traversable LT?	N/A	N/A	Flare Traversable RT?	N/A
N/A	Landing Length (in)	N/A	N/A	DWS Provided?	N/A
N/A	Landing Width (in)	N/A	N/A	DWS Contrast?	N/A
N/A	Landing Slope (%)	N/A	N/A	DWS Length (in)	N/A
N/A	Landing X Slope (%)	N/A	N/A	DWS Full Width?	N/A
N/A	Landing Curb? (Y/N)	N/A	N/A	DWS Offset (in)	N/A
N/A	Shared Landing?	N/A			
N/A	Gutter Ponding?	N/A	N/A	Gutter Slope (%)	N/A
N/A	Gutter Lip Ht (in)	N/A	N/A	Gutter X Slope (%)	N/A
N/A	Painted X Walk1?	No	N/A	Painted X Walk2?	No
	X Walk 1 Direction	To W		X Walk 2 Direction	To E
N/A	X Walk 1 Width (in)	N/A	N/A	X Walk 2 Width (in)	N/A
	X Walk 1 Slope (%)	2.8		X Walk 2 Slope (%)	3.4
	X Walk 1 X Slope (%)	5.1		X Walk 2 X Slope (%)	1.8

N/A	Ramp inside XWalk1?	N/A	N/A	Ramp inside XWalk2?	N/A
	Road Slope (%)	3.3	N/A	Clear Space?	N/A
	Road X Slope (%)	4.2	N/A	Clear Space to XWalk (in)	N/A
N/A	Any Obstructions?	N/A	N/A	Storm Grate/Utility Hazard?	N/A
	Obstruction Type			Storm Grate/Utility Type	
		N/A			N/A
		Yes		Surface Condition? (G/P)	Good

**Remove & Replace Curb Ramp With Two New Directional Ramps or Equivalent.**

Total Cost: \$ 3200.00

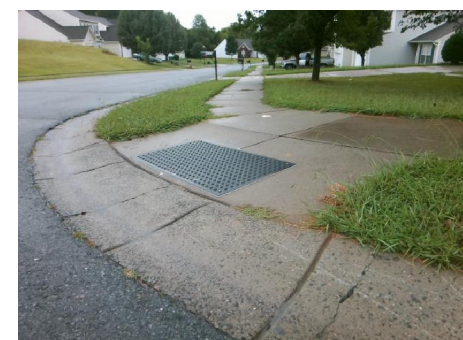
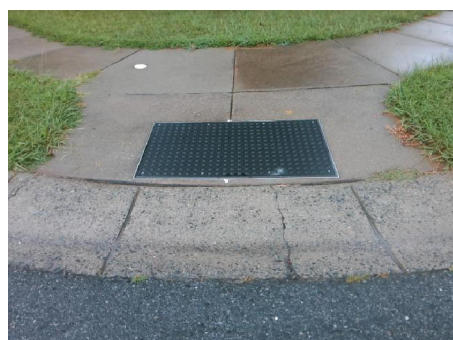
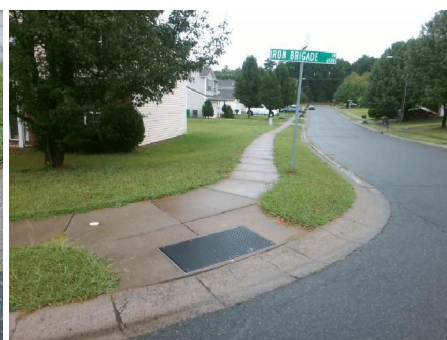
Street 1 Name IRON BRIGADE LN  
 Stop Condition-Street 2 StopSign  
 Street 2 Name BRAWER FARM DR  
 Stop Condition-Street 1 None
