Access Compliance Report

Public Rights-of-Way

(Curb Ramps)

Intersection ID: 47278	Main Street: BERNADINE_CT	Cross Street: CARRINGTON_FOREST_LN	Location: SE
ADA ID: F89824A16C2F	Ramp Type: PerpDiag	Initial Pass/Fail: Fail	Overall Compliance: No
Severity Score: 22.5			
Codes/Mitigation Info/Possible Solution		Field Measurements/Component Compliance

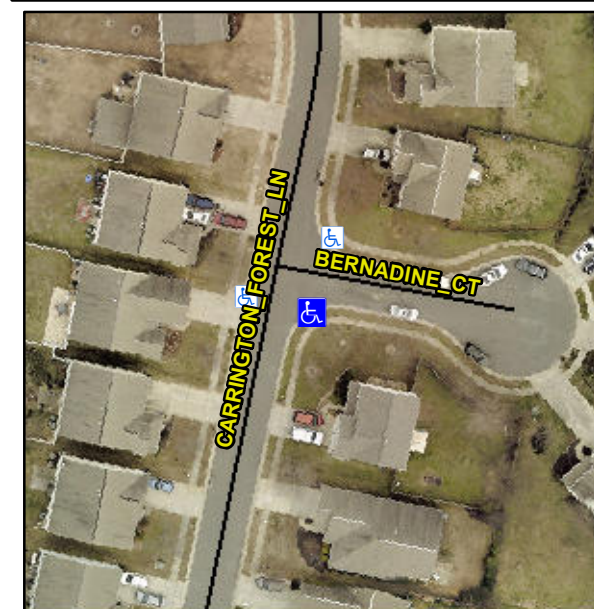
Not Found, R304.5.1, R304.2.2, R304.5.3

Compliance	Description	Data	Compliance	Description	Data
N/A	Ramp Length (in)	48.0	No	Ramp Slope (%)	8.5
No	Ramp Width (in)	44.5	No	Ramp XSlope (%)	2.3
N/A	Flare Type LT	N/A	N/A	Flare Type RT	N/A
N/A	Flare Slope LT (%)	N/A	N/A	Flare Slope RT (%)	N/A
N/A	Flare Traversable LT?	N/A	N/A	Flare Traversable RT?	N/A
N/A	Landing Length (in)	N/A	N/A	DWS Provided?	N/A
N/A	Landing Width (in)	N/A	N/A	DWS Contrast?	N/A
N/A	Landing Slope (%)	N/A	N/A	DWS Length (in)	N/A
N/A	Landing X Slope (%)	N/A	N/A	DWS Full Width?	N/A
N/A	Landing Curb? (Y/N)	N/A	N/A	DWS Offset (in)	N/A
N/A	Shared Landing?	N/A			
N/A	Gutter Ponding?	N/A	N/A	Gutter Slope (%)	N/A
N/A	Gutter Lip Ht (in)	N/A	N/A	Gutter X Slope (%)	N/A
N/A	Painted X Walk1?	No	N/A	Painted X Walk2?	No
	X Walk 1 Direction	To N		X Walk 2 Direction	To W
N/A	X Walk 1 Width (in)	N/A	N/A	X Walk 2 Width (in)	N/A
	X Walk 1 Slope (%)	4.3		X Walk 2 Slope (%)	2.3
	X Walk 1 X Slope (%)	0.2		X Walk 2 X Slope (%)	5.7

N/A	Ramp inside XWalk1?	N/A	N/A	Ramp inside XWalk2?	N/A
	Road Slope (%)	0.9	N/A	Clear Space?	N/A
	Road X Slope (%)	5.4	N/A	Clear Space to XWalk (in)	N/A
N/A	Any Obstructions?	N/A	N/A	Storm Grate/Utility Hazard?	N/A
	Obstruction Type			Storm Grate/Utility Type	
		N/A			N/A
			Yes	Surface Condition? (G/P)	Good

Possible Solutions:

Remove & Replace Curb Ramp With Two New Directional Ramps or Equivalent.
