## Access Compliance Report Public Rights-of-Way (Curb Ramps)

Intersection ID: 3101 Main Street: ALABASTER\_CT Cross Street: MINERAL\_RIDGE\_WY Location: E

ADA ID: F8B3C4E9AAA9 Ramp Type: Perp Initial Pass/Fail: Fail Overall Compliance: No Severity Score: 36.25

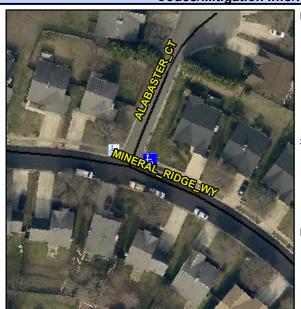
Field Measurements/Component Compliance							
Comp	liance Description	Data	Comp	liance Description	Data		
N/A	Ramp Length (in)	94.0	Yes	Ramp Slope (%)	5.1		
No	Ramp Width (in)	31.5	No	Ramp XSlope (%)	2.6		
N/A	Flare Type LT	N/A	N/A	Flare Type RT	N/A		
N/A	Flare Slope LT (%)	N/A	N/A	Flare Slope RT (%)	N/A		
N/A	Flare Traversable LT?	N/A	N/A	Flare Traversable RT?	N/A		
N/A	Landing Length (in)	N/A	N/A	DWS Provided?	N/A		
N/A	Landing Width (in)	N/A	N/A	DWS Contrast?	N/A		
N/A	Landing Slope (%)	N/A	N/A	DWS Length (in)	N/A		
N/A	Landing X Slope (%)	N/A	N/A	DWS Full Width?	N/A		
N/A	Landing Curb? (Y/N)	N/A	N/A	DWS Offset (in)	N/A		
N/A	Shared Landing?	N/A					
N/A	Gutter Ponding?	N/A	N/A	Gutter Slope (%)	N/A		
N/A	Gutter Lip Ht (in)	N/A	N/A	Gutter X Slope (%)	N/A		
N/A	Painted X Walk1?	No	N/A	Painted X Walk2?	N/A		
	X Walk 1 Direction	To NW		X Walk 2 Direction	N/A		
N/A	X Walk 1 Width (in)	N/A	N/A	X Walk 2 Width (in)	N/A

X Walk 1 Slope (%)	1.2		X Walk 2 Slope (%)	N/A		
	X Walk 1 X Slope (%)	3.9		X Walk 2 X Slope (%)	N/A		
N/A	Ramp inside XWalk1?	N/A	N/A	Ramp inside XWalk2?	N/A		
	Road Slope (%)	N/A	N/A	Clear Space?	N/A		
	Road X Slope (%)	N/A	N/A	Clear Space to XWalk (in)	N/A		
N/A	Any Obstructions?	N/A	N/A	Storm Grate/Utility Hazard?	N/A		
	Obstruction Type			Storm Grate/Utility Type			
		N/A			N/A		
			Yes	Surface Condition? (G/P)	Good

Possible Solutions:						
Remove & Replace Entire Ramp.						
4						
Surveyor Notes:						
N/A						
PROW/ADA:						
Not Found, R304.5.1, R304.5.3						
•
