Access Compliance Report

Public Rights-of-Way

(Curb Ramps)

Intersection ID: 5588	Main Street: CARVER_BV	Cross Street: ROCKWELL_BV	Location: E
ADA ID: F8CF4EA50CE9	Ramp Type: Para	Initial Pass/Fail: Fail	Overall Compliance: No
Severity Score: 17.5			
Codes/Mitigation Info/Possible Solution		Field Measurements/Component Compliance

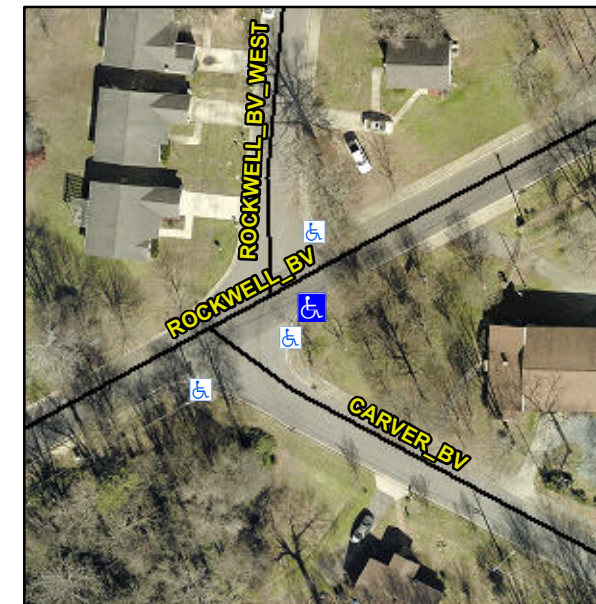
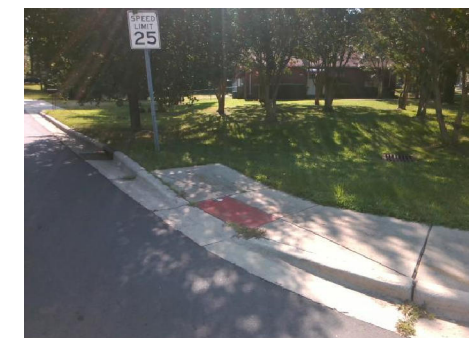
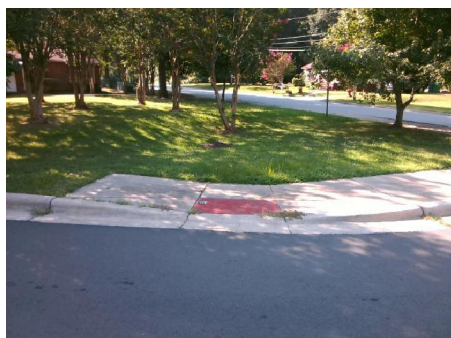
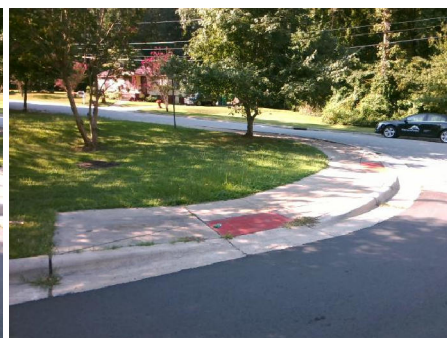
RT RP < 5%, NO LT SW

Compliance	Description	Data	Compliance	Description	Data
N/A	Ramp Length LT (in)	68.0	N/A	Ramp Length RT (in)	56.0
No	Ramp Width LT (in)	35.0	No	Ramp Width RT (in)	35.0
Yes	Ramp Slope LT (%)	6.8	Yes	Ramp Slope RT (%)	4.5
Yes	Ramp XSlope LT (%)	1.6	Yes	Ramp XSlope RT (%)	0.2
N/A	Landing Length (in)	N/A	N/A	DWS Provided?	N/A
N/A	Landing Width (in)	N/A	N/A	DWS Contrast?	N/A
N/A	Landing Slope (%)	N/A	N/A	DWS Length (in)	N/A
N/A	Landing X Slope (%)	N/A	N/A	DWS Full Width?	N/A
N/A	Landing Curb? (Y/N)	N/A	N/A	DWS Offset (in)	N/A
N/A	Shared Landing?	N/A			
N/A	Gutter Ponding?	N/A	N/A	Gutter Slope (%)	N/A
N/A	Gutter Lip Ht (in)	N/A	N/A	Gutter X Slope (%)	N/A
N/A	Painted X Walk1?	No	N/A	Painted X Walk2?	N/A
	X Walk 1 Direction	To NE		X Walk 2 Direction	N/A
N/A	X Walk 1 Width (in)	N/A	N/A	X Walk 2 Width (in)	N/A
	X Walk 1 Slope (%)	1.8		X Walk 2 Slope (%)	N/A
	X Walk 1 X Slope (%)	2.0		X Walk 2 X Slope (%)	N/A
N/A	Ramp inside XWalk1?	N/A	N/A	Ramp inside XWalk2?	N/A

Road Slope (%)	N/A	N/A	Clear Space?	N/A
	Road X Slope (%)	N/A	N/A	Clear Space to XWalk (in)	N/A
N/A	Any Obstructions?	N/A	N/A	Storm Grate/Utility Hazard?	N/A
	Obstruction Type			Storm Grate/Utility Type	
		N/A			N/A
			Yes	Surface Condition? (G/P)	Good
			N/A	Curb Slope (%)	10.0

Possible Solutions:

Remove & Replace Entire Ramp.
