Access Compliance Report

Public Rights-of-Way

(Curb Ramps)

Intersection ID: 22011	Main Street: SOUTH_BV	Cross Street: HILL_RD	Location: NE
ADA ID: F8D38D466191	Ramp Type: PerpDiag	Initial Pass/Fail: Fail	Overall Compliance: No
Severity Score: 18.75			
Codes/Mitigation Info/Possible Solution		Field Measurements/Component Compliance

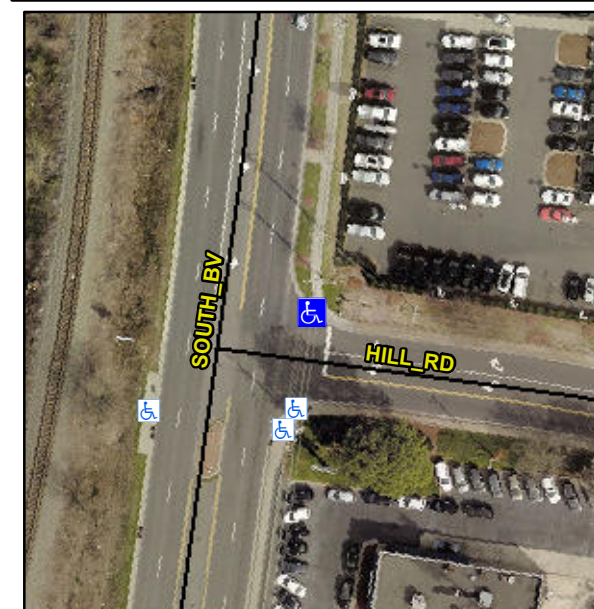
Compliance	Description	Data	Compliance	Description	Data
N/A	Ramp Length (in)	71.0	Yes	Ramp Slope (%)	5.9
No	Ramp Width (in)	35.0	No	Ramp XSlope (%)	2.2
N/A	Flare Type LT	N/A	N/A	Flare Type RT	N/A
N/A	Flare Slope LT (%)	N/A	N/A	Flare Slope RT (%)	N/A
N/A	Flare Traversable LT?	N/A	N/A	Flare Traversable RT?	N/A
N/A	Landing Length (in)	N/A	N/A	DWS Provided?	N/A
N/A	Landing Width (in)	N/A	N/A	DWS Contrast?	N/A
N/A	Landing Slope (%)	N/A	N/A	DWS Length (in)	N/A
N/A	Landing X Slope (%)	N/A	N/A	DWS Full Width?	N/A
N/A	Landing Curb? (Y/N)	N/A	N/A	DWS Offset (in)	N/A
N/A	Shared Landing?	N/A			
N/A	Gutter Ponding?	N/A	N/A	Gutter Slope (%)	N/A
N/A	Gutter Lip Ht (in)	N/A	N/A	Gutter X Slope (%)	N/A
N/A	Painted X Walk1?	No	N/A	Painted X Walk2?	No
	X Walk 1 Direction	To W		X Walk 2 Direction	To S
N/A	X Walk 1 Width (in)	N/A	N/A	X Walk 2 Width (in)	N/A
	X Walk 1 Slope (%)	1.6		X Walk 2 Slope (%)	2.1
	X Walk 1 X Slope (%)	1.3		X Walk 2 X Slope (%)	3.2

N/A	Ramp inside XWalk1?	N/A	N/A	Ramp inside XWalk2?	N/A
	Road Slope (%)	2.6	N/A	Clear Space?	N/A
	Road X Slope (%)	3.1	N/A	Clear Space to XWalk (in)	N/A
N/A	Any Obstructions?	N/A	N/A	Storm Grate/Utility Hazard?	N/A
	Obstruction Type			Storm Grate/Utility Type	
		N/A			N/A
		Yes		Surface Condition? (G/P)	Good

Remove & Replace Curb Ramp With Two New Directional Ramps or Equivalent.

R304.5.1, R304.5.3
