Access Compliance Report

Public Rights-of-Way

(Curb Ramps)

| Intersection ID: 10017663 | Main Street: STATESVILLE_AV | Cross Street: N/A | Location: W |

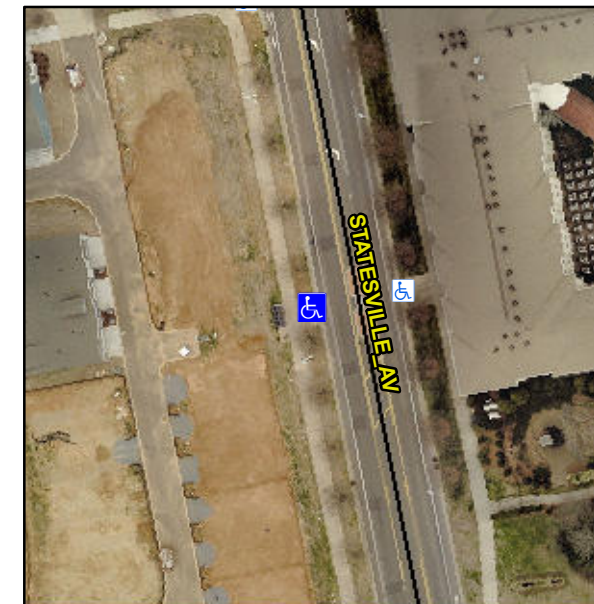
| ADA ID: F8F03B0852D4 | Ramp Type: Perp | Initial Pass/Fail: Fail | Overall Compliance: No |

Not Found, R304.5.1

| Compliance | Description | Data | Compliance | Description | Data |
|---|---|---|---|---|---|
| No | Ramp Width (in) | 47.5 | Yes | Ramp XSlope (%) | 2.5 |

Remove & Replace Entire Ramp.
