Access Compliance Report

Public Rights-of-Way

(Curb Ramps)

Intersection ID: 50338	Main Street: HERMISTON_ST	Cross Street: CASTLECOVE_RD	Location: SE
ADA ID: F90A71446A51	Ramp Type: PerpDiag	Initial Pass/Fail: Fail	Overall Compliance: No
		Severity Score: 12.5

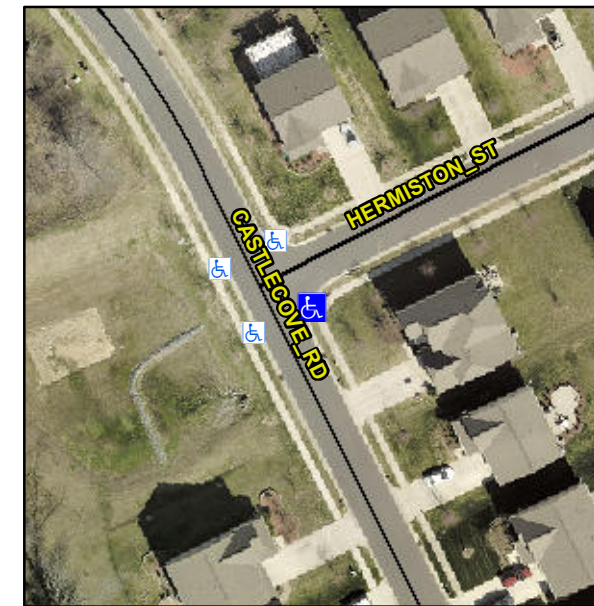
Compliance	Description	Data	Compliance	Description	Data
N/A	Ramp Length (in)	49.0	No	Ramp Slope (%)	11.8
Yes	Ramp Width (in)	48.0	Yes	Ramp XSlope (%)	0.3
N/A	Flare Type LT	N/A	N/A	Flare Type RT	N/A
N/A	Flare Slope LT (%)	N/A	N/A	Flare Slope RT (%)	N/A
N/A	Flare Traversable LT?	N/A	N/A	Flare Traversable RT?	N/A
N/A	Landing Length (in)	N/A	N/A	DWS Provided?	N/A
N/A	Landing Width (in)	N/A	N/A	DWS Contrast?	N/A
N/A	Landing Slope (%)	N/A	N/A	DWS Length (in)	N/A
N/A	Landing X Slope (%)	N/A	N/A	DWS Full Width?	N/A
N/A	Landing Curb? (Y/N)	N/A	N/A	DWS Offset (in)	N/A
N/A	Shared Landing?	N/A			
N/A	Gutter Ponding?	N/A	N/A	Gutter Slope (%)	N/A
N/A	Gutter Lip Ht (in)	N/A	N/A	Gutter X Slope (%)	N/A
N/A	Painted X Walk1?	No	N/A	Painted X Walk2?	No
	X Walk 1 Direction	To NW		X Walk 2 Direction	To SW
N/A	X Walk 1 Width (in)	N/A	N/A	X Walk 2 Width (in)	N/A
	X Walk 1 Slope (%)	0.5		X Walk 2 Slope (%)	4.1
	X Walk 1 X Slope (%)	0.0		X Walk 2 X Slope (%)	1.3

N/A	Ramp inside XWalk1?	N/A	N/A	Ramp inside XWalk2?	N/A
	Road Slope (%)	1.7	N/A	Clear Space?	N/A
	Road X Slope (%)	0.9	N/A	Clear Space to XWalk (in)	N/A
N/A	Any Obstructions?	N/A	N/A	Storm Grate/Utility Hazard?	N/A
	Obstruction Type			Storm Grate/Utility Type	
		N/A			N/A
			Yes	Surface Condition? (G/P)	Good

Possible Solutions:

Remove & Replace Curb Ramp With Two New Directional Ramps or Equivalent.

R304.2.2

\$ 3200.00
