Access Compliance Report

Public Rights-of-Way

(Curb Ramps)

Intersection ID: 31215	Main Street: OLDEHURST_PL	Cross Street: WRAYHILL_DR	Location: SW
ADA ID: F924F256B381	Ramp Type: PerpDiag	Initial Pass/Fail: Fail	Overall Compliance: No
Severity Score: 33.75			
Codes/Mitigation Info/Possible Solution		Field Measurements/Component Compliance

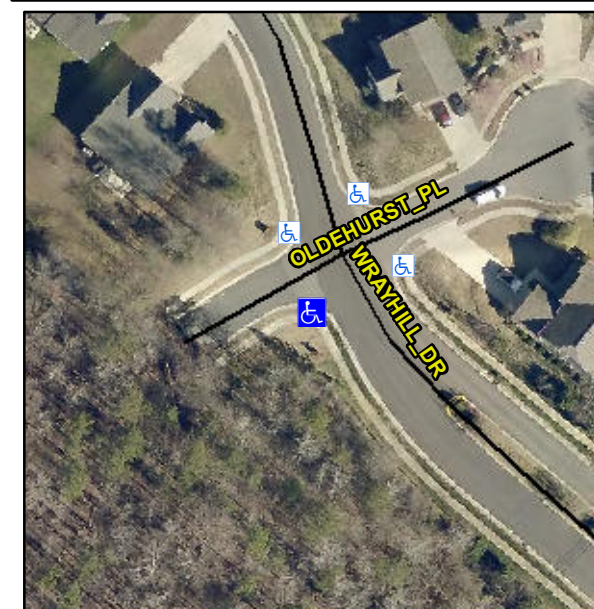
Not Found, R304.5.1, R304.2.2

Compliance	Description	Data	Compliance	Description	Data
N/A	Ramp Length (in)	52.0	No	Ramp Slope (%)	12.0
No	Ramp Width (in)	42.0	Yes	Ramp XSlope (%)	0.7
N/A	Flare Type LT	N/A	N/A	Flare Type RT	N/A
N/A	Flare Slope LT (%)	N/A	N/A	Flare Slope RT (%)	N/A
N/A	Flare Traversable LT?	N/A	N/A	Flare Traversable RT?	N/A
N/A	Landing Length (in)	N/A	N/A	DWS Provided?	N/A
N/A	Landing Width (in)	N/A	N/A	DWS Contrast?	N/A
N/A	Landing Slope (%)	N/A	N/A	DWS Length (in)	N/A
N/A	Landing X Slope (%)	N/A	N/A	DWS Full Width?	N/A
N/A	Landing Curb? (Y/N)	N/A	N/A	DWS Offset (in)	N/A
N/A	Shared Landing?	N/A			
N/A	Gutter Ponding?	N/A	N/A	Gutter Slope (%)	N/A
N/A	Gutter Lip Ht (in)	N/A	N/A	Gutter X Slope (%)	N/A
N/A	Painted X Walk1?	No	N/A	Painted X Walk2?	No
	X Walk 1 Direction	To E		X Walk 2 Direction	To N
N/A	X Walk 1 Width (in)	N/A	N/A	X Walk 2 Width (in)	N/A
	X Walk 1 Slope (%)	1.3		X Walk 2 Slope (%)	0.6
	X Walk 1 X Slope (%)	0.9		X Walk 2 X Slope (%)	1.2

N/A	Ramp inside XWalk1?	N/A	N/A	Ramp inside XWalk2?	N/A
	Road Slope (%)	0.1	N/A	Clear Space?	N/A
	Road X Slope (%)	0.8	N/A	Clear Space to XWalk (in)	N/A
N/A	Any Obstructions?	N/A	N/A	Storm Grate/Utility Hazard?	N/A
	Obstruction Type			Storm Grate/Utility Type	
		N/A			N/A
		Yes		Surface Condition? (G/P)	Good

Remove & Replace Curb Ramp With Two New Directional Ramps or Equivalent.

Total Cost: \$ 3200.00
