## **Access Compliance Report Public Rights-of-Way** (Curb Ramps)

Intersection ID: 42560 Main Street: GLENWOOD DR Cross Street: N\_I-85\_EXIT\_35\_RA Location: W **Overall Compliance: No** ADA ID: F9391B59C53D Ramp Type: Perp Initial Pass/Fail: Fail **Severity Score:** 22.5

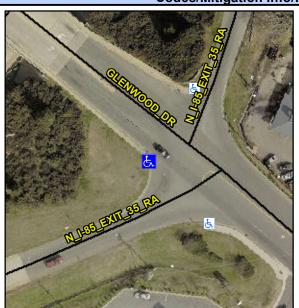
Field Measurements/Component Compliance						
Compli	iance Description	Data	Comp	liance Description	Data	
N/A	Ramp Length (in)	59.0	No	Ramp Slope (%)	8.8	
No	Ramp Width (in)	44.0	No	Ramp XSlope (%)	2.5	
N/A	Flare Type LT	N/A	N/A	Flare Type RT	N/A	
N/A	Flare Slope LT (%)	N/A	N/A	Flare Slope RT (%)	N/A	
N/A	Flare Traversable LT?	N/A	N/A	Flare Traversable RT?	N/A	
N/A	Landing Length (in)	N/A	N/A	DWS Provided?	N/A	
N/A	Landing Width (in)	N/A	N/A	DWS Contrast?	N/A	
N/A	Landing Slope (%)	N/A	N/A	DWS Length (in)	N/A	
N/A	Landing X Slope (%)	N/A	N/A	DWS Full Width?	N/A	
N/A	Landing Curb? (Y/N)	N/A	N/A	DWS Offset (in)	N/A	
N/A	Shared Landing?	N/A				
N/A	Gutter Ponding?	N/A	N/A	Gutter Slope (%)	N/A	
N/A	Gutter Lip Ht (in)	N/A	N/A	Gutter X Slope (%)	N/A	
N/A	Painted X Walk1?	No	N/A	Painted X Walk2?	N/A	
	X Walk 1 Direction	To SE		X Walk 2 Direction	N/A	
N/A	X Walk 1 Width (in)	N/A	N/A	X Walk 2 Width (in)	N/A	
	X Walk 1 Slope (%)	0.3		X Walk 2 Slope (%)	N/A

X Walk 1 X Slope (%)	0.7		X Walk 2 X Slope (%)	N/A	
N/A	Ramp inside XWalk1?	N/A	N/A	Ramp inside XWalk2?	N/A	
	Road Slope (%)	N/A	N/A	Clear Space?	N/A	
	Road X Slope (%)	N/A	N/A	Clear Space to XWalk (in)	N/A	
N/A	Any Obstructions?	N/A	N/A	Storm Grate/Utility Hazard?	N/A	
	Obstruction Type			Storm Grate/Utility Type		
		N/A			N/A	
			Yes	Surface Condition? (G/P)	Good

Possible Solutions: Remove & Replace Entire Ramp. Surveyor Notes: N/A PROW/ADA: Not Found, R304.5.1, R304.2.2, R304.5.3
