Access Compliance Report

Public Rights-of-Way

(Curb Ramps)

Intersection ID: 17815	Main Street: IDLEWILD_RD	Cross Street: VESTAL_PL	Location: SW
ADA ID: F93B33C591C4	Ramp Type: PerpDiag	Initial Pass/Fail: Fail	Overall Compliance: No
Severity Score: 37.5			
Codes/Mitigation Info/Possible Solution		Field Measurements/Component Compliance

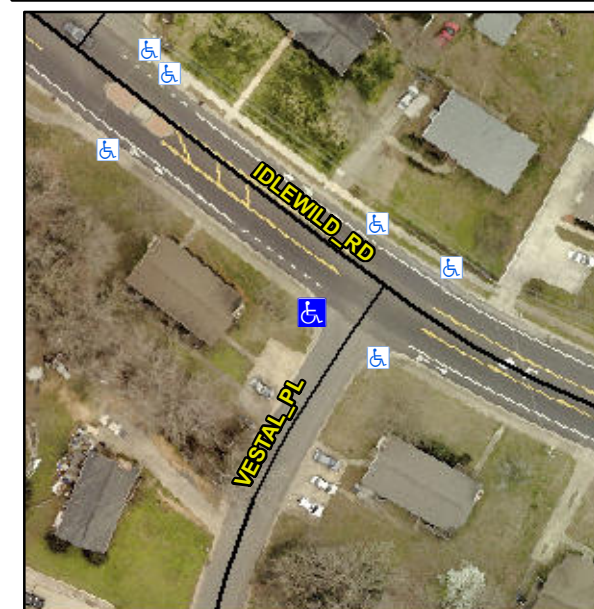
R304.2.2, R304.5.3

Compliance	Description	Data	Compliance	Description	Data
N/A	Ramp Length (in)	60.0	No	Ramp Slope (%)	10.8
Yes	Ramp Width (in)	48.0	No	Ramp XSlope (%)	8.2
N/A	Flare Type LT	N/A	N/A	Flare Type RT	N/A
N/A	Flare Slope LT (%)	N/A	N/A	Flare Slope RT (%)	N/A
N/A	Flare Traversable LT?	N/A	N/A	Flare Traversable RT?	N/A
N/A	Landing Length (in)	N/A	N/A	DWS Provided?	N/A
N/A	Landing Width (in)	N/A	N/A	DWS Contrast?	N/A
N/A	Landing Slope (%)	N/A	N/A	DWS Length (in)	N/A
N/A	Landing X Slope (%)	N/A	N/A	DWS Full Width?	N/A
N/A	Landing Curb? (Y/N)	N/A	N/A	DWS Offset (in)	N/A
N/A	Shared Landing?	N/A			
N/A	Gutter Ponding?	N/A	N/A	Gutter Slope (%)	N/A
N/A	Gutter Lip Ht (in)	N/A	N/A	Gutter X Slope (%)	N/A
N/A	Painted X Walk1?	No	N/A	Painted X Walk2?	No
	X Walk 1 Direction	To SE		X Walk 2 Direction	To NE
N/A	X Walk 1 Width (in)	N/A	N/A	X Walk 2 Width (in)	N/A
	X Walk 1 Slope (%)	4.0		X Walk 2 Slope (%)	1.7
	X Walk 1 X Slope (%)	2.3		X Walk 2 X Slope (%)	6.4

N/A	Ramp inside XWalk1?	N/A	N/A	Ramp inside XWalk2?	N/A
	Road Slope (%)	6.2	N/A	Clear Space?	N/A
	Road X Slope (%)	0.9	N/A	Clear Space to XWalk (in)	N/A
N/A	Any Obstructions?	N/A	N/A	Storm Grate/Utility Hazard?	N/A
	Obstruction Type			Storm Grate/Utility Type	
		N/A			N/A
			Yes	Surface Condition? (G/P)	Good

Remove & Replace Curb Ramp With Two New Directional Ramps or Equivalent.
