# Access Compliance Report

## Public Rights-of-Way

### (Curb Ramps)

Intersection ID: 48946	Main Street: DAVID_JENNINGS_AV	Cross Street: MITCHELL_GRANT_WY	Location: N
ADA ID: F956DEA47506	Ramp Type: Combination1	Initial Pass/Fail: Fail	Overall Compliance: No
Severity Score: 33.75			
Codes/Mitigation Info/Possible Solution		Field Measurements/Component Compliance

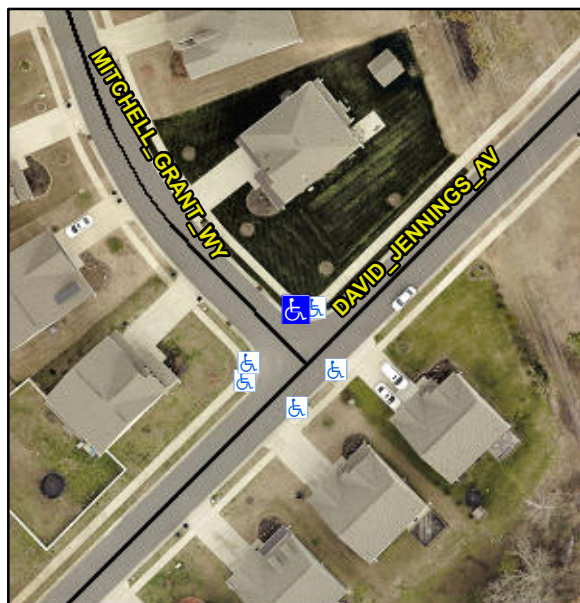
**CURB WIDTH 38.5**

**Not Found, R304.5.1, R304.2.2, R304.5.3, R304.3.2**

Compliance	Description	Data	Compliance	Description	Data
N/A	Ramp Length LT (in)	12.5	N/A	Ramp Length RT (in)	1.0
Yes	Ramp Width LT (in)	58.0	Yes	Ramp Width RT (in)	61.0
Yes	Ramp Slope LT (%)	7.0	No	Ramp Slope RT (%)	9.6
No	Ramp XSlope LT (%)	2.4	Yes	Ramp XSlope RT (%)	0.3
N/A	Ramp Length (in)	47.0	No	Ramp Slope (%)	8.8
No	Ramp Width (in)	47.0	No	Ramp XSlope (%)	5.9
N/A	Flare Type LT	N/A	N/A	Flare Type RT	N/A
N/A	Flare Slope LT (%)	N/A	N/A	Flare Slope RT (%)	N/A
N/A	Flare Traversable LT?	N/A	N/A	Flare Traversable RT?	N/A
N/A	Landing Length (in)	N/A	N/A	DWS Provided?	N/A
N/A	Landing Width (in)	N/A	N/A	DWS Contrast?	N/A
N/A	Landing Slope (%)	N/A	N/A	DWS Length (in)	N/A
N/A	Landing X Slope (%)	N/A	N/A	DWS Full Width?	N/A
N/A	Landing Curb? (Y/N)	N/A	N/A	DWS Offset (in)	N/A
N/A	Shared Landing?	N/A			
N/A	Gutter Ponding?	N/A	N/A	Gutter Slope (%)	N/A
N/A	Gutter Lip Ht (in)	N/A	N/A	Gutter X Slope (%)	N/A
N/A	Painted X Walk1?	No	N/A	Painted X Walk2?	N/A

**Remove & Replace Entire Ramp.**

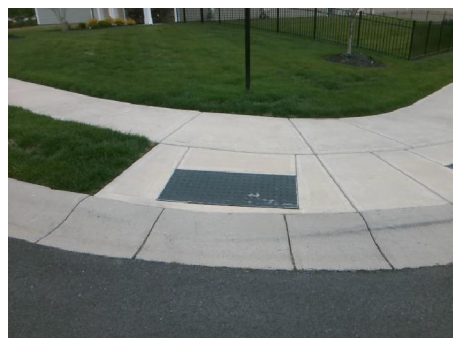
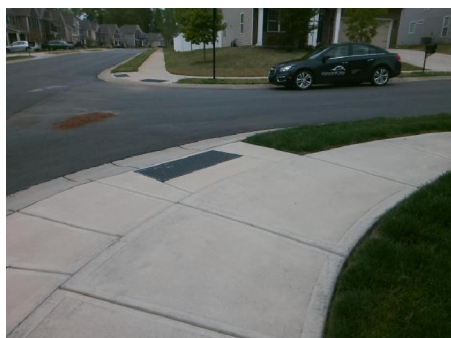
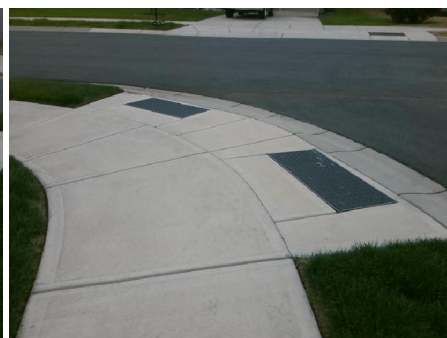
X Walk 1 Direction	To SW		X Walk 2 Direction	N/A
	X Walk 1 Width (in)	N/A		X Walk 2 Width (in)	N/A
	X Walk 1 Slope (%)	2.8		X Walk 2 Slope (%)	N/A
	X Walk 1 X Slope (%)	1.4		X Walk 2 X Slope (%)	N/A
N/A	Ramp inside XWalk1?	N/A	N/A	Ramp inside XWalk2?	N/A
	Road Slope (%)	N/A		Clear Space?	N/A
	Road X Slope (%)	N/A	N/A	Clear Space to XWalk (in)	N/A
			N/A	Any Obstruction?	N/A
				Obstruction Type	N/A
			N/A	Storm Grate/Utility Hazard?	N/A
				Storm Grate/Utility Type	N/A
			Yes	Surface Condition? (G/P)	Good
				Curb Slope (%)	16.6
