Access Compliance Report

Public Rights-of-Way

(Curb Ramps)

Intersection ID: 25192	Main Street: CANE_FIELD_DR	Cross Street: ROLLING_SKY_DR	Location: NW
ADA ID: F96E9FF873BF	Ramp Type: PerpDiag	Initial Pass/Fail: Fail	Overall Compliance: No
		Severity Score: 25

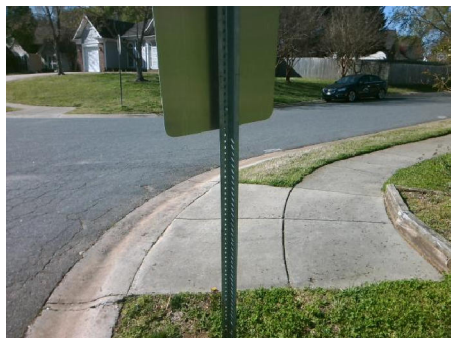
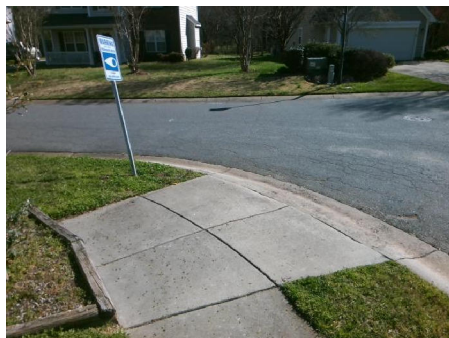
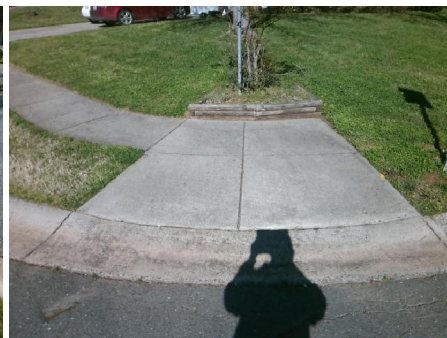
Not Found, R304.2.2

Compliance	Description	Data	Compliance	Description	Data
N/A	Ramp Length (in)	51.0	No	Ramp Slope (%)	14.4
Yes	Ramp Width (in)	48.0	Yes	Ramp XSlope (%)	0.6
N/A	Flare Type LT	N/A	N/A	Flare Type RT	N/A
N/A	Flare Slope LT (%)	N/A	N/A	Flare Slope RT (%)	N/A
N/A	Flare Traversable LT?	N/A	N/A	Flare Traversable RT?	N/A
N/A	Landing Length (in)	N/A	N/A	DWS Provided?	N/A
N/A	Landing Width (in)	N/A	N/A	DWS Contrast?	N/A
N/A	Landing Slope (%)	N/A	N/A	DWS Length (in)	N/A
N/A	Landing X Slope (%)	N/A	N/A	DWS Full Width?	N/A
N/A	Landing Curb? (Y/N)	N/A	N/A	DWS Offset (in)	N/A
N/A	Shared Landing?	N/A			
N/A	Gutter Ponding?	N/A	N/A	Gutter Slope (%)	N/A
N/A	Gutter Lip Ht (in)	N/A	N/A	Gutter X Slope (%)	N/A
N/A	Painted X Walk1?	No	N/A	Painted X Walk2?	No
	X Walk 1 Direction	To SE		X Walk 2 Direction	To NE
N/A	X Walk 1 Width (in)	N/A	N/A	X Walk 2 Width (in)	N/A
	X Walk 1 Slope (%)	1.0		X Walk 2 Slope (%)	1.3
	X Walk 1 X Slope (%)	1.2		X Walk 2 X Slope (%)	0.9

N/A	Ramp inside XWalk1?	N/A	N/A	Ramp inside XWalk2?	N/A
	Road Slope (%)	1.8	N/A	Clear Space?	N/A
	Road X Slope (%)	2.3	N/A	Clear Space to XWalk (in)	N/A
N/A	Any Obstructions?	N/A	N/A	Storm Grate/Utility Hazard?	N/A
	Obstruction Type			Storm Grate/Utility Type	
		N/A			N/A
			Yes	Surface Condition? (G/P)	Good

Remove & Replace Curb Ramp With Two New Directional Ramps or Equivalent.
