# Access Compliance Report

## Public Rights-of-Way

### (Curb Ramps)

Intersection ID: 11207	Main Street: GRANDIN_RD	Cross Street: W_4TH_ST	Location: S
ADA ID: F9713E3BFB57	Ramp Type: Perp	Initial Pass/Fail: Fail	Overall Compliance: No
			Severity Score: 13.75

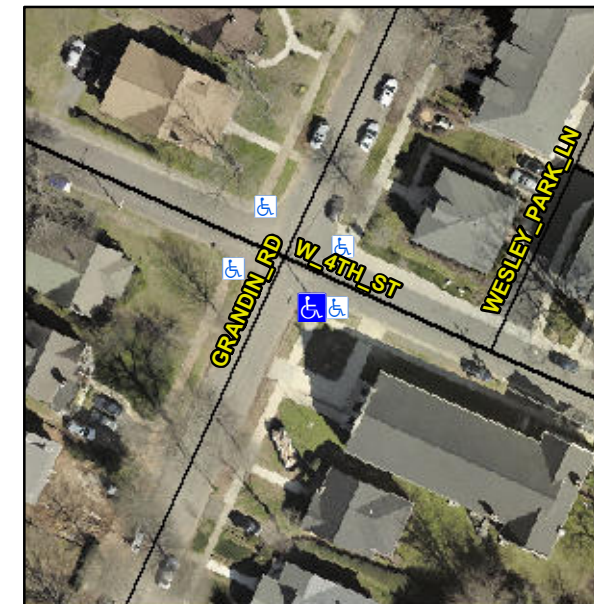
**Not Found, R304.2.2, R304.5.3**

Compliance	Description	Data	Compliance	Description	Data
N/A	Ramp Length (in)	29.0	No	Ramp Slope (%)	8.4
Yes	Ramp Width (in)	60.0	No	Ramp XSlope (%)	3.4
N/A	Flare Type LT	N/A	N/A	Flare Type RT	N/A
N/A	Flare Slope LT (%)	N/A	N/A	Flare Slope RT (%)	N/A
N/A	Flare Traversable LT?	N/A	N/A	Flare Traversable RT?	N/A
N/A	Landing Length (in)	N/A	N/A	DWS Provided?	N/A
N/A	Landing Width (in)	N/A	N/A	DWS Contrast?	N/A
N/A	Landing Slope (%)	N/A	N/A	DWS Length (in)	N/A
N/A	Landing X Slope (%)	N/A	N/A	DWS Full Width?	N/A
N/A	Landing Curb? (Y/N)	N/A	N/A	DWS Offset (in)	N/A
N/A	Shared Landing?	N/A			
N/A	Gutter Ponding?	N/A	N/A	Gutter Slope (%)	N/A
N/A	Gutter Lip Ht (in)	N/A	N/A	Gutter X Slope (%)	N/A
N/A	Painted X Walk1?	No	N/A	Painted X Walk2?	N/A
	X Walk 1 Direction	To NW		X Walk 2 Direction	N/A
N/A	X Walk 1 Width (in)	N/A	N/A	X Walk 2 Width (in)	N/A
	X Walk 1 Slope (%)	3.3		X Walk 2 Slope (%)	N/A
	X Walk 1 X Slope (%)	0.3		X Walk 2 X Slope (%)	N/A

N/A	Ramp inside XWalk1?	N/A	N/A	Ramp inside XWalk2?	N/A
	Road Slope (%)	N/A	N/A	Clear Space?	N/A
	Road X Slope (%)	N/A	N/A	Clear Space to XWalk (in)	N/A
N/A	Any Obstructions?	N/A	N/A	Storm Grate/Utility Hazard?	N/A
	Obstruction Type			Storm Grate/Utility Type	
		N/A			N/A
			Yes	Surface Condition? (G/P)	Good

**Remove & Replace Entire Ramp.**

Total Cost: \$ 1850.00
