# Access Compliance Report

## Public Rights-of-Way

### (Curb Ramps)

Intersection ID: 48423	Main Street: EVANTON_LOCH_RD	Cross Street: BEDLINGTON_RD	Location: S
ADA ID: F9A5F9EDFDB9	Ramp Type: PerpDiag	Initial Pass/Fail: Fail	Overall Compliance: No
Codes/Mitigation Info/Possible Solution			Severity Score: 25
			Field Measurements/Component Compliance

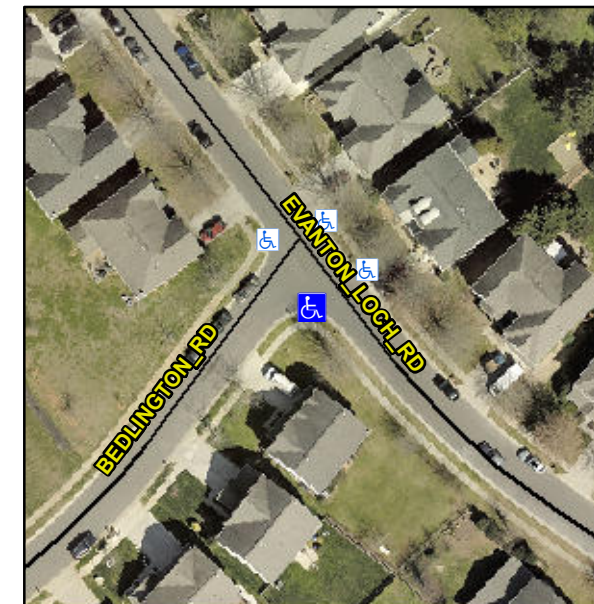
Compliance	Description	Data	Compliance	Description	Data
N/A	Ramp Length (in)	48.0	No	Ramp Slope (%)	8.7
Yes	Ramp Width (in)	48.0	No	Ramp XSlope (%)	5.5
N/A	Flare Type LT	N/A	N/A	Flare Type RT	N/A
N/A	Flare Slope LT (%)	N/A	N/A	Flare Slope RT (%)	N/A
N/A	Flare Traversable LT?	N/A	N/A	Flare Traversable RT?	N/A
N/A	Landing Length (in)	N/A	N/A	DWS Provided?	N/A
N/A	Landing Width (in)	N/A	N/A	DWS Contrast?	N/A
N/A	Landing Slope (%)	N/A	N/A	DWS Length (in)	N/A
N/A	Landing X Slope (%)	N/A	N/A	DWS Full Width?	N/A
N/A	Landing Curb? (Y/N)	N/A	N/A	DWS Offset (in)	N/A
N/A	Shared Landing?	N/A			
N/A	Gutter Ponding?	N/A	N/A	Gutter Slope (%)	N/A
N/A	Gutter Lip Ht (in)	N/A	N/A	Gutter X Slope (%)	N/A
N/A	Painted X Walk1?	No	N/A	Painted X Walk2?	No
	X Walk 1 Direction	To NE		X Walk 2 Direction	To NW
N/A	X Walk 1 Width (in)	N/A	N/A	X Walk 2 Width (in)	N/A
	X Walk 1 Slope (%)	4.8		X Walk 2 Slope (%)	1.1
	X Walk 1 X Slope (%)	1.0		X Walk 2 X Slope (%)	3.1

N/A	Ramp inside XWalk1?	N/A	N/A	Ramp inside XWalk2?	N/A
	Road Slope (%)	5.0	N/A	Clear Space?	N/A
	Road X Slope (%)	3.0	N/A	Clear Space to XWalk (in)	N/A
N/A	Any Obstructions?	N/A	N/A	Storm Grate/Utility Hazard?	N/A
	Obstruction Type			Storm Grate/Utility Type	
		N/A			N/A
			Yes	Surface Condition? (G/P)	Good

**Remove & Replace Curb Ramp With Two New Directional Ramps or Equivalent.**

**R304.2.2, R304.5.3**
