Access Compliance Report

Public Rights-of-Way

(Curb Ramps)

| Intersection ID: 18567 | Main Street: MICHAEL_BAKER_PL | Cross Street: RUNNYMEDE_LN | Location: SW |

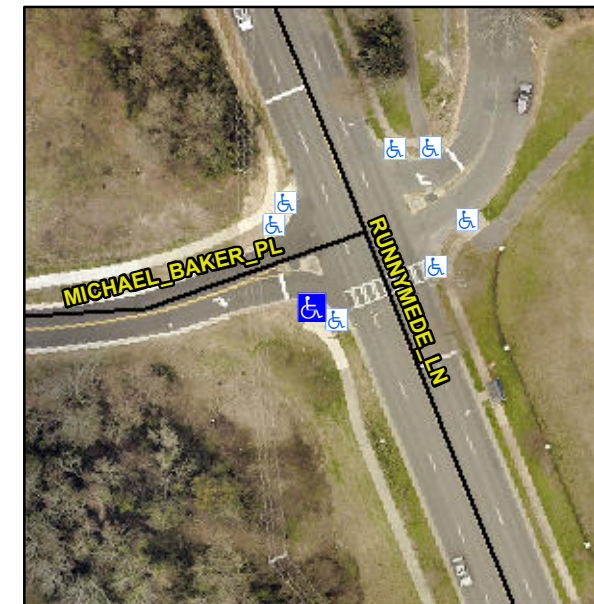
| ADA ID: F9B209AF9037 | Ramp Type: Perp | Initial Pass/Fail: Fail | Overall Compliance: No |

Not Found, R304.2.2

| Compliance | Description | Data | Compliance | Description | Data |
|---|---|---|---|---|---|
| N/A | Ramp Length (in) | 93.0 | No | Ramp Slope (%) | 8.5 |

Remove & Replace Entire Ramp.
