## Access Compliance Report Public Rights-of-Way (Curb Ramps)

Intersection ID: 10035065Main Street: PROVIDENCE\_RDCross Street: N/ALocation:NEADA ID: F9B2573FB54FRamp Type: PerpDiagInitial Pass/Fail: FailOverall Compliance: NoSeverity Score: 12.5

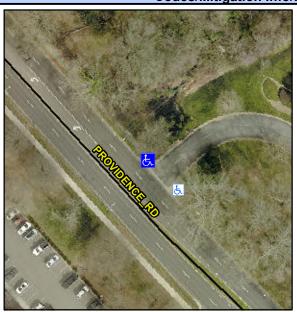
Not Found, R304.2.2

Compliance Description <u>Data</u> Compliance Description Data No N/A Ramp Length (in) 67.0 Ramp Slope (%) 11.0 Yes Ramp XSlope (%) Yes Ramp Width (in) 48.0 0.5 N/A N/A Flare Type LT N/A Flare Type RT N/A N/A N/A N/A Flare Slope RT (%) N/A Flare Slope LT (%) N/A Flare Traversable LT? N/A N/A Flare Traversable RT? N/A N/A N/A N/A DWS Provided? N/A Landing Length (in) N/A Landing Width (in) N/A N/A **DWS Contrast?** N/A N/A N/A N/A Landing Slope (%) DWS Length (in) N/A N/A Landing X Slope (%) N/A N/A DWS Full Width? N/A N/A Landing Curb? (Y/N) N/A N/A DWS Offset (in) N/A N/A N/A Shared Landing? N/A **Gutter Ponding?** N/A N/A Gutter Slope (%) N/A N/A Gutter Lip Ht (in) N/A N/A Gutter X Slope (%) N/A N/A Painted X Walk1? No N/A Painted X Walk2? No X Walk 1 Direction To SW X Walk 2 Direction To SE N/A N/A N/A X Walk 1 Width (in) X Walk 2 Width (in) X Walk 1 Slope (%) 2.8 X Walk 2 Slope (%) 2.2 X Walk 1 X Slope (%) 5.1 X Walk 2 X Slope (%) 1.5 N/A N/A N/A Ramp inside XWalk2? N/A Ramp inside XWalk1? Road Slope (%) 0.4 N/A Clear Space? N/A N/A Road X Slope (%) Clear Space to XWalk (in) N/A 4.8 N/A N/A N/A Any Obstructions? Storm Grate/Utility Hazard? N/A **Obstruction Type** Storm Grate/Utility Type N/A N/A Yes Surface Condition? (G/P) Good

Remove & Replace Curb Ramp With
Two New Directional Ramps or
Equivalent.
