Access Compliance Report Public Rights-of-Way (Curb Ramps)

Intersection ID: 9126
 Main Street:
 REDBUD_ST
 Cross Street:
 PITTS_DR
 Location:
 SW

ADA ID: F9CDCD95A9DE
 Ramp Type:
 Para
 Initial Pass/Fail:
 Fail
 Overall Compliance:
 No
 Severity Score:
 22.5

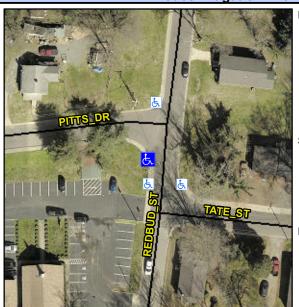
RT RP < 5%

Field Measurements/Component Compliance					
Compliance Description		Data	Comp	Compliance Description	
N/A	Ramp Length LT (in)	66.0	N/A	Ramp Length RT (in)	66.0
No	Ramp Width LT (in)	47.0	Yes	Ramp Width RT (in)	48.0
No	Ramp Slope LT (%)	8.5	Yes	Ramp Slope RT (%)	2.2
No	Ramp XSlope LT (%)	2.6	Yes	Ramp XSlope RT (%)	1.7
N/A	Landing Length (in)	N/A	N/A	DWS Provided?	N/A
N/A	Landing Width (in)	N/A	N/A	DWS Contrast?	N/A
N/A	Landing Slope (%)	N/A	N/A	DWS Length (in)	N/A
N/A	Landing X Slope (%)	N/A	N/A	DWS Full Width?	N/A
N/A	Landing Curb? (Y/N)	N/A	N/A	DWS Offset (in)	N/A
N/A	Shared Landing?	N/A			
N/A	Gutter Ponding?	N/A	N/A	Gutter Slope (%)	N/A
N/A	Gutter Lip Ht (in)	N/A	N/A	Gutter X Slope (%)	N/A
N/A	Painted X Walk1?	No	N/A	Painted X Walk2?	N/A
	X Walk 1 Direction	To N		X Walk 2 Direction	N/A
N/A	X Walk 1 Width (in)	N/A	N/A	X Walk 2 Width (in)	N/A
	X Walk 1 Slope (%)	1.5		X Walk 2 Slope (%)	N/A
	X Walk 1 X Slope (%)	5.9		X Walk 2 X Slope (%)	N/A

N/A	Ramp inside XWalk1?	N/A	N/A	Ramp inside XWalk2?	N/A
	Road Slope (%)	N/A	N/A	Clear Space?	N/A
	Road X Slope (%)	N/A	N/A	Clear Space to XWalk (in)	N/A
N/A	Any Obstructions?	N/A	N/A	Storm Grate/Utility Hazard?	N/A
	Obstruction Type			Storm Grate/Utility Type	
		N/A			N/A
			Yes	Surface Condition? (G/P)	Good
			N/A	Curb Slope (%)	18.1
	-2,7

Remove & Replace Entire Ramp.

R304.5.1, R304.3.2, R304.5.3
