# Access Compliance Report

## Public Rights-of-Way

### (Curb Ramps)

Intersection ID: 32316	Main Street: NEW_PROVIDENCE_LN	Cross Street: WOODCLIFF_CT	Location: S
ADA ID: F9CDD60FE373	Ramp Type: PerpDiag	Initial Pass/Fail: Fail	Overall Compliance: No
Severity Score: 18.75			
Codes/Mitigation Info/Possible Solution		Field Measurements/Component Compliance

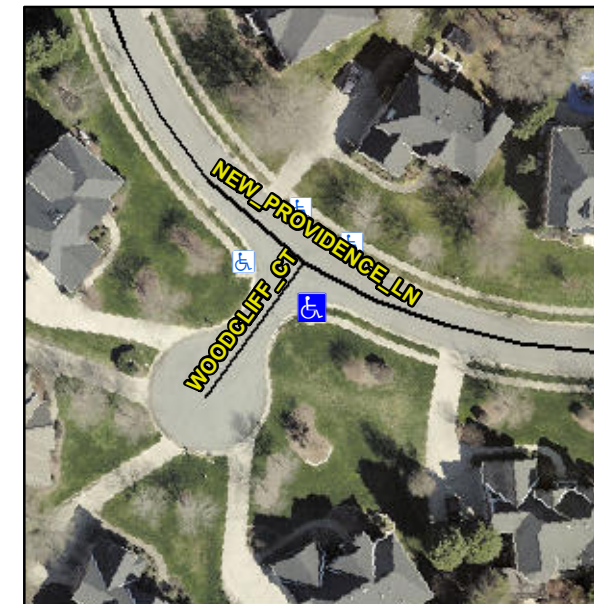
**Not Found, R304.5.1, R304.5.3**

Compliance	Description	Data	Compliance	Description	Data
N/A	Ramp Length (in)	50.5	Yes	Ramp Slope (%)	7.6
No	Ramp Width (in)	35.5	No	Ramp XSlope (%)	3.9
N/A	Flare Type LT	N/A	N/A	Flare Type RT	N/A
N/A	Flare Slope LT (%)	N/A	N/A	Flare Slope RT (%)	N/A
N/A	Flare Traversable LT?	N/A	N/A	Flare Traversable RT?	N/A
N/A	Landing Length (in)	N/A	N/A	DWS Provided?	N/A
N/A	Landing Width (in)	N/A	N/A	DWS Contrast?	N/A
N/A	Landing Slope (%)	N/A	N/A	DWS Length (in)	N/A
N/A	Landing X Slope (%)	N/A	N/A	DWS Full Width?	N/A
N/A	Landing Curb? (Y/N)	N/A	N/A	DWS Offset (in)	N/A
N/A	Shared Landing?	N/A			
N/A	Gutter Ponding?	N/A	N/A	Gutter Slope (%)	N/A
N/A	Gutter Lip Ht (in)	N/A	N/A	Gutter X Slope (%)	N/A
N/A	Painted X Walk1?	No	N/A	Painted X Walk2?	No
	X Walk 1 Direction	To NE		X Walk 2 Direction	To NW
N/A	X Walk 1 Width (in)	N/A	N/A	X Walk 2 Width (in)	N/A
	X Walk 1 Slope (%)	0.5		X Walk 2 Slope (%)	1.3
	X Walk 1 X Slope (%)	3.8		X Walk 2 X Slope (%)	4.2

N/A	Ramp inside XWalk1?	N/A	N/A	Ramp inside XWalk2?	N/A
	Road Slope (%)	3.6	N/A	Clear Space?	N/A
	Road X Slope (%)	5.8	N/A	Clear Space to XWalk (in)	N/A
N/A	Any Obstructions?	N/A	N/A	Storm Grate/Utility Hazard?	N/A
	Obstruction Type			Storm Grate/Utility Type	
		N/A			N/A
			Yes	Surface Condition? (G/P)	Good

**Remove & Replace Curb Ramp With Two New Directional Ramps or Equivalent.**
