Access Compliance Report

Public Rights-of-Way

(Curb Ramps)

Intersection ID: 16448	Main Street: DENNING_PL	Cross Street: E W T HARRIS BV	Location: SE
ADA ID: F9E60844E23C	Ramp Type: PerpDiag	Initial Pass/Fail: Fail	Overall Compliance: No
Severity Score: 21.25			
Codes/Mitigation Info/Possible Solution		Field Measurements/Component Compliance

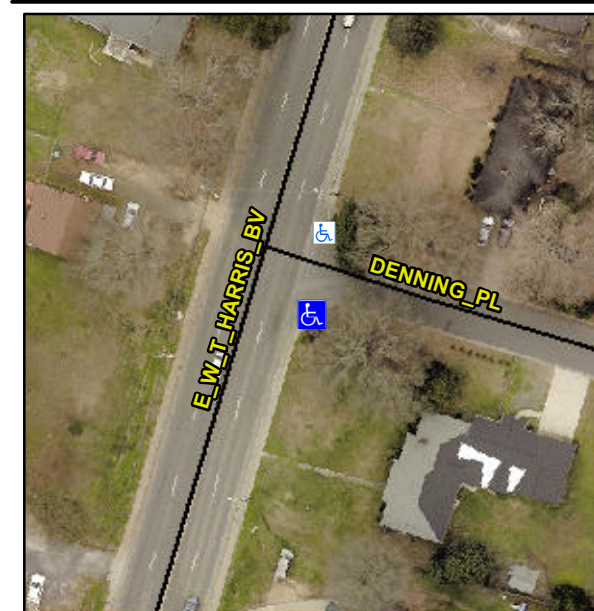
Not Found, R304.5.1, R304.2.2

Compliance	Description	Data	Compliance	Description	Data
N/A	Ramp Length (in)	60.0	No	Ramp Slope (%)	8.4
No	Ramp Width (in)	36.0	Yes	Ramp XSlope (%)	0.4
N/A	Flare Type LT	N/A	N/A	Flare Type RT	N/A
N/A	Flare Slope LT (%)	N/A	N/A	Flare Slope RT (%)	N/A
N/A	Flare Traversable LT?	N/A	N/A	Flare Traversable RT?	N/A
N/A	Landing Length (in)	N/A	N/A	DWS Provided?	N/A
N/A	Landing Width (in)	N/A	N/A	DWS Contrast?	N/A
N/A	Landing Slope (%)	N/A	N/A	DWS Length (in)	N/A
N/A	Landing X Slope (%)	N/A	N/A	DWS Full Width?	N/A
N/A	Landing Curb? (Y/N)	N/A	N/A	DWS Offset (in)	N/A
N/A	Shared Landing?	N/A			
N/A	Gutter Ponding?	N/A	N/A	Gutter Slope (%)	N/A
N/A	Gutter Lip Ht (in)	N/A	N/A	Gutter X Slope (%)	N/A
N/A	Painted X Walk1?	No	N/A	Painted X Walk2?	No
	X Walk 1 Direction	To NE		X Walk 2 Direction	To NW
N/A	X Walk 1 Width (in)	N/A	N/A	X Walk 2 Width (in)	N/A
	X Walk 1 Slope (%)	2.3		X Walk 2 Slope (%)	1.3
	X Walk 1 X Slope (%)	2.0		X Walk 2 X Slope (%)	2.4

N/A	Ramp inside XWalk1?	N/A	N/A	Ramp inside XWalk2?	N/A
	Road Slope (%)	3.6	N/A	Clear Space?	N/A
	Road X Slope (%)	1.6	N/A	Clear Space to XWalk (in)	N/A
N/A	Any Obstructions?	N/A	N/A	Storm Grate/Utility Hazard?	N/A
	Obstruction Type			Storm Grate/Utility Type	
		N/A			N/A
			Yes	Surface Condition? (G/P)	Good

Remove & Replace Curb Ramp With Two New Directional Ramps or Equivalent.
