# Access Compliance Report

## Public Rights-of-Way

### (Curb Ramps)

Intersection ID: 5967	Main Street: N_TRYON_ST	Cross Street: MCCULLOUGH_DR	Location: SE
ADA ID: F9F6C73D79E7	Ramp Type: BlendTrans1	Initial Pass/Fail: Fail	Overall Compliance: No
		Severity Score: 12.5

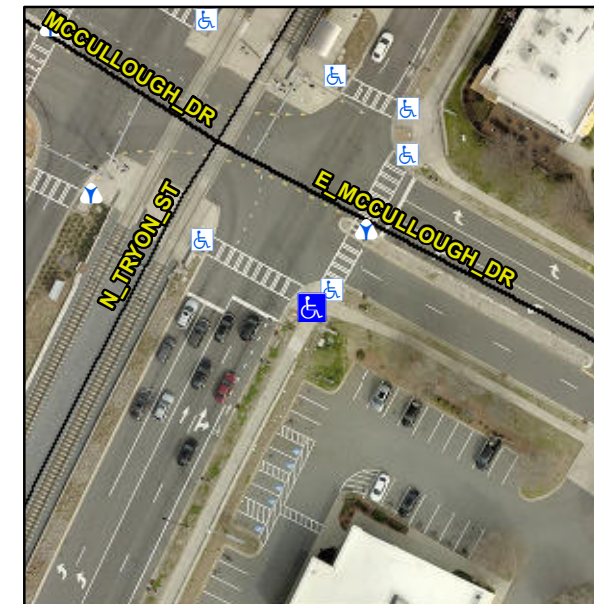
Compliance	Description	Data	Compliance	Description	Data
N/A	Ramp Length (in)	94.5	Yes	BlendTrans Slope (%)	1.5
Yes	Ramp Width (in)	48.0	No	BlendTrans XSlope (%)	5.3
N/A	Flare Type LT	N/A	N/A	Flare Type RT	N/A
N/A	Flare Slope LT (%)	N/A	N/A	Flare Slope RT (%)	N/A
N/A	Flare Traversable LT?	N/A	N/A	Flare Traversable RT?	N/A
N/A	Landing Length (in)	N/A	N/A	DWS Provided?	N/A
N/A	Landing Width (in)	N/A	N/A	DWS Contrast?	N/A
N/A	Landing Slope (%)	N/A	N/A	DWS Length (in)	N/A
N/A	Landing X Slope (%)	N/A	N/A	DWS Full Width?	N/A
N/A	Landing Curb? (Y/N)	N/A	N/A	DWS Offset (in)	N/A
N/A	Shared Landing?	N/A			
N/A	Gutter Ponding?	N/A	N/A	Gutter Slope (%)	N/A
N/A	Gutter Lip Ht (in)	2.0	N/A	Gutter X Slope (%)	N/A
N/A	Painted X Walk1?	No	N/A	Painted X Walk2?	N/A
	X Walk 1 Direction	To NW		X Walk 2 Direction	N/A
	X Walk 1 Width (in)	N/A		X Walk 2 Width (in)	N/A
	X Walk 1 Slope (%)	2.3		X Walk 2 Slope (%)	N/A
	X Walk 1 X Slope (%)	1.3		X Walk 2 X Slope (%)	N/A

N/A	Ramp inside XWalk1?	N/A	N/A	Ramp inside XWalk2?	N/A
	Road Slope (%)	1.3		Clear Space?	N/A
	Road X Slope (%)	2.3	N/A	Clear Space to XWalk (in)	N/A
N/A	Any Obstructions?	N/A	N/A	Storm Grate/Utility Hazard?	N/A
	Obstruction Type			Storm Grate/Utility Type	
		N/A			N/A
			Yes	Surface Condition? (G/P)	Good
			N/A	Curb Slope (%)	1.8

**Remove & Replace Curb Ramp With Two New Directional Ramps or Equivalent.**

**R304.5.3**
