Access Compliance Report

Public Rights-of-Way

(Curb Ramps)

Intersection ID: N/A		Main Street: CITY_PARK_DR		Cross Street: ARBOR_LOOP_DR		Location:		W	
ADA ID: F9FB7C5180AF		Ramp Type: Directional1		Initial Pass/Fail: Fail		Overall Compliance: No		Severity Score: 1.25	
Codes/Mitigation Info/Possible Solution				Field Measurements/Component Compliance					
<div>

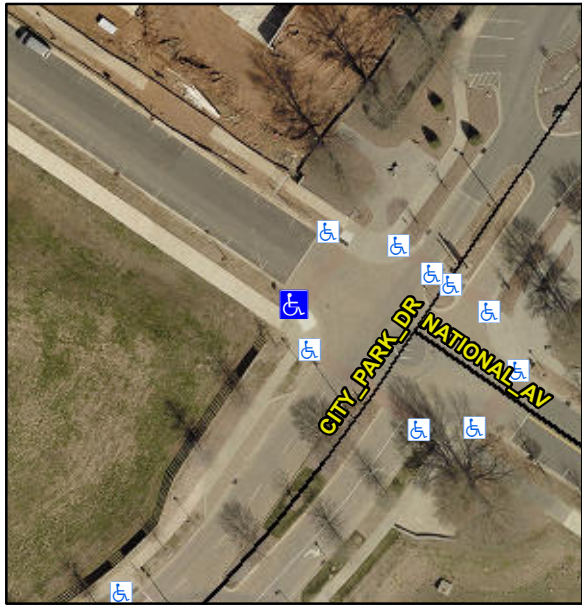
No	Ramp XSlope (%)	3.7			
				N/A	Flare Type LT	N/A	N/A	Flare Type RT	N/A
				N/A	Flare Slope LT (%)	N/A	N/A	Flare Slope RT (%)	0.0
				N/A	Flare Traversable LT?	N/A	N/A	Flare Traversable RT?	N/A
				N/A	Landing Length (in)	0.0	N/A	DWS Provided?	N/A
				N/A	Landing Width (in)	0.0	N/A	DWS Contrast?	N/A
				N/A	Landing Slope (%)	0.0	N/A	DWS Length (in)	N/A
				N/A	Landing X Slope (%)	0.0	N/A	DWS Full Width?	N/A
				N/A	Landing Curb? (Y/N)	N/A	N/A	DWS Offset LT (in)	N/A
				N/A	Shared Landing?	N/A	N/A	DWS Offset RT (in)	N/A
				N/A	Gutter Ponding?	0.0	N/A	Gutter Slope (%)	N/A
				N/A	Gutter Lip Ht (in)	0.0	N/A	Gutter X Slope (%)	N/A
				N/A	Painted X Walk1?	Yes		Road Slope (%)	3.8
					X Walk 1 Direction	To N		Road X Slope (%)	2.2
					X Walk 1 Width (in)	96.0		Clear Space?	N/A
					X Walk 1 Slope (%)	3.8	N/A	Clear Space to XWalk (in)	N/A
					X Walk 1 X Slope (%)	2.2	N/A	Storm Grate/Utility Hazard?	N/A

N/A	Ramp inside XWalk1?	Yes		Storm Grate/Utility Type	
				N/A	Any Obstructions?	N/A			N/A
					Obstruction Type		Yes	Surface Condition? (G/P)	Good
							N/A	Curb Slope (%)	4.4

</div> <div>Possible Solutions:</div> <div>Remove & Replace Entire Ramp.</div> <div>Surveyor Notes:</div> <div>N/A</div> <div>PROW/ADA:</div> <div>R304.5.3</div> <div>Street 1 Name</div> <div>NATIONAL AV</div> <div>Stop Condition-Street 1</div> <div>StopSign</div> <div>Street 2 Name</div> <div>N/A</div> <div>Stop Condition-Street 2</div> <div>N/A</div> <div>Total Cost:</div> <div>\$</div> <div>1600.00</div>				Compliance	Description	Data	Compliance	Description	Data
				N/A	Ramp Length (in)	98.0	N/A	Grade Break?	N/A
				Yes	Ramp Width (in)	72.0	N/A	Grade Break Slope (%)	0.0
				Yes	Ramp Slope (%)	3.0	N/A	Grade Break XSlope (%)	0.0
